# FREEWAY CROSSING NON-MOTORIZED RETROFIT

FOR WASHTENAW AREA TRANSPORTATION STUDY

Final Report: June 30, 2020  
HRC Job No. 20191021

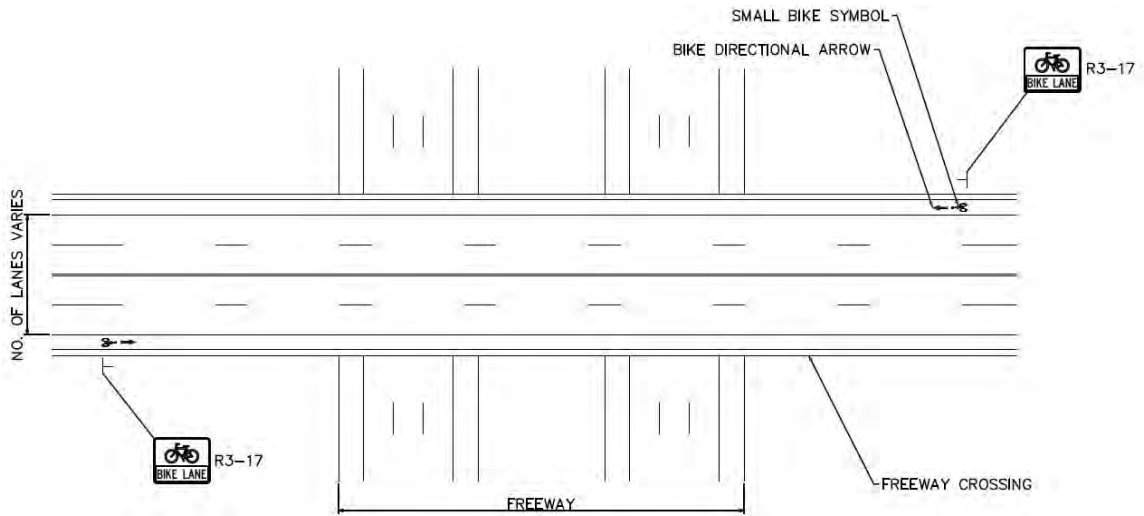
Figure ES-1: Plan View of Bike Lane Added to Existing Crossing

- **Bike Lane:** Designates a portion of the roadway for preferential use by bicyclists with a BIKE LANE sign (R3-17) and a bicycle lane symbol marking with an arrow. Best practices indicate it is desirable to have bike lane widths of five or six feet. The bike lanes recommended in this study are 6 feet wide on each side unless otherwise noted, so at least 12 feet must be available to add bike lanes to a crossing. If the bike lanes are adjacent to a guardrail or other physical barrier, an additional width of four feet is required to account for the two-foot shy on both sides. A buffered bike lane could also be considered if space is available. **Figure ES-1** shows a plan view of an existing crossing with a bike lane on each side.

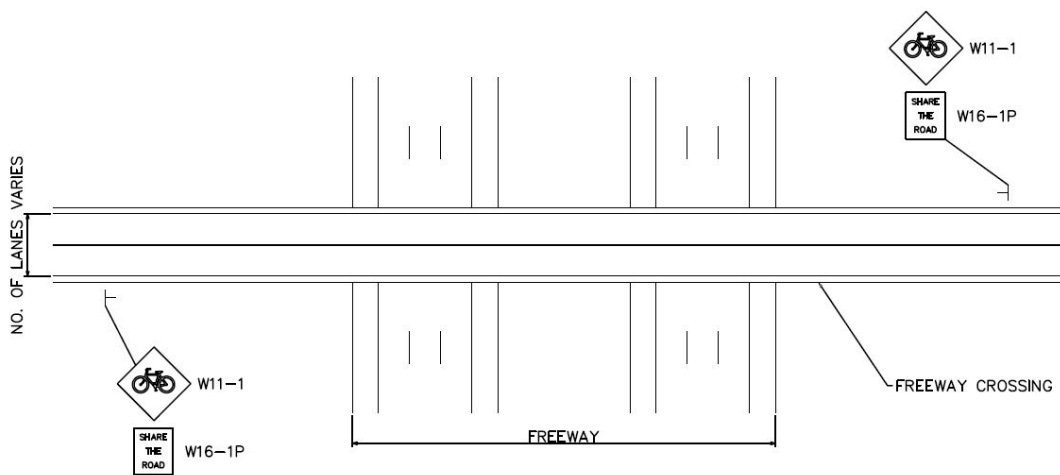
Figure ES-3: Plan View of Bicycle Warning Added to Existing Crossing

- **Bicycle Warning:** Warns motorists to watch for bicyclists traveling along the roadway with a Bicycle Warning sign (W11-1) and SHARE THE ROAD plaque (W16-1P). The crossing does not have adequate width available to add bike lanes after subtracting the travel way from the clear roadway width and has a speed limit of 40 miles per hour or more. **Figure ES-3** shows a plan view of an existing crossing with a bicycle warning on each side.

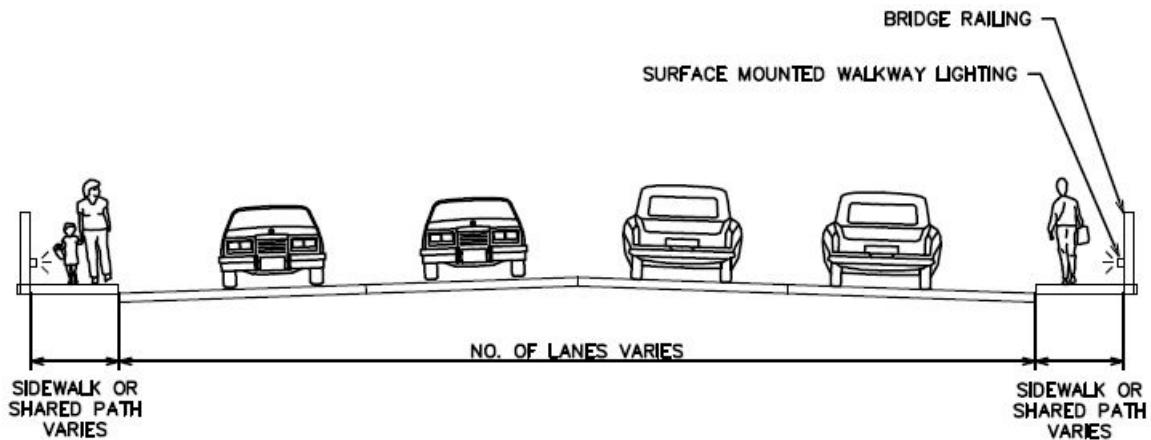
Figure ES-4: Typical Section of Walkway Lighting Added to Existing Crossing

- **Walkway Lighting:** Increases visibility of non-motorized users at nighttime. **Figure ES-4** shows a typical section of an existing crossing with surface mounted walkway lighting on each side.
- **Curved Fencing:** Limits the exposure of non-motorized traffic to the freeway. **Figure ES-5** shows a typical section of an existing crossing with curved fencing on each side.
- **Separation Barrier:** Protects non-motorized users from motorists. **Figure ES-6** shows a typical section of an existing crossing with a two-foot wide separation barrier on each side.

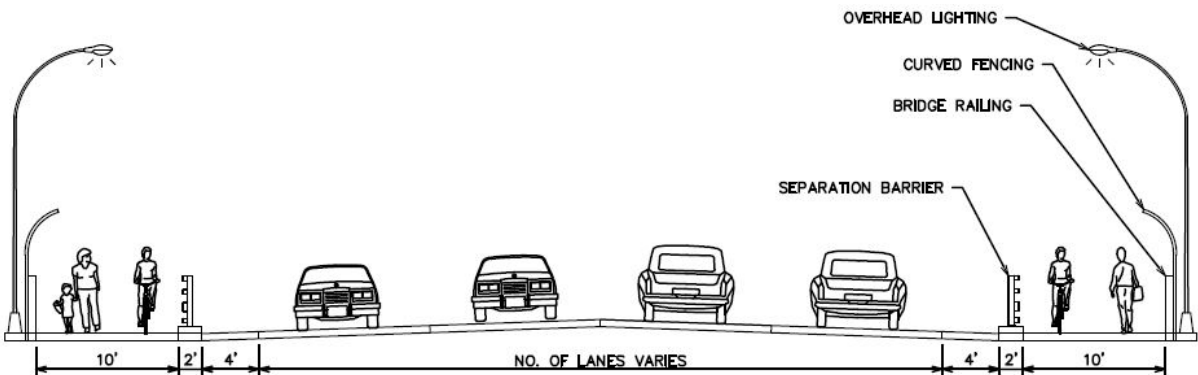
- Shared Path with Separation Barrier, Curved Fencing, and Lighting:** Provides access and separation, limits freeway exposure, and increases nighttime visibility for non-motorized users. Figure ES-7 shows a typical section of a crossing with a 10-foot wide shared path, 2-foot wide separation barrier, curved fencing, and overhead lighting.

Source: Adapted from MDOT Bridge Design Guides Section 6.05.02

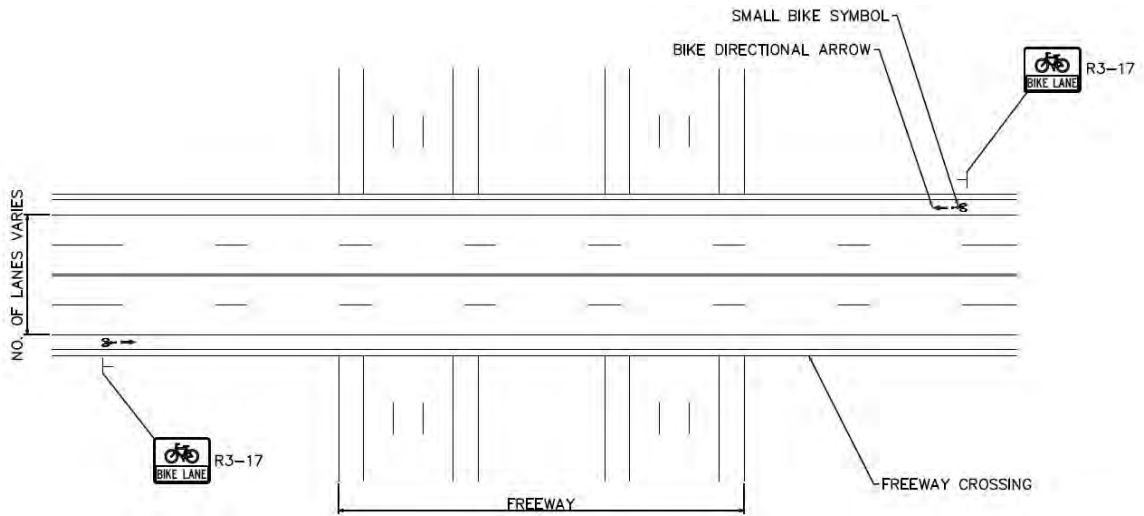
Figure 2: Plan View of Bike Lane Added to Existing Crossing

- **Bike Lane:** Designates a portion of the roadway for preferential use by bicyclists with a BIKE LANE sign (R3-17) and a bicycle lane symbol marking with an arrow. Best practices indicate it is desirable to have bike lane widths of five or six feet. The bike lanes recommended in this study are 6 feet wide on each side unless otherwise noted, so at least 12 feet must be available to add bike lanes to a crossing. If the bike lanes are adjacent to a guardrail or other physical barrier, an additional width of four feet is required to account for the two-foot shy on both sides. A buffered bike lane could also be considered if space is available. **Figure 2** shows a plan view of an existing crossing with a bike lane on each side.

Adding a bike lane to both sides of a crossing costs approximately between \$2,000 – \$4,000, depending on the length of the crossing. This improvement includes a solid white bike lane line and new pavement marking lines (broken white and double solid yellow lines) on the crossing, and a BIKE LANE sign (R3-17) and a bicycle lane symbol marking with an arrow in advance of the crossing.

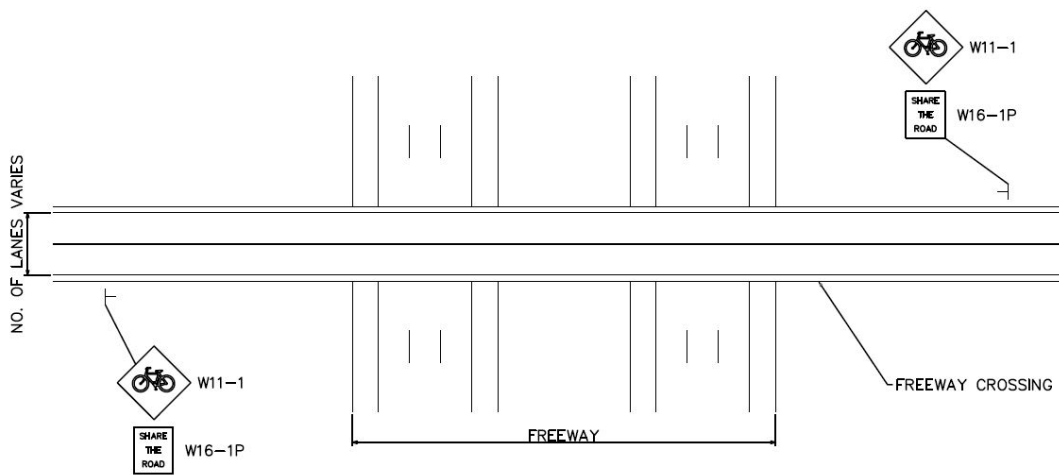
Figure 4: Plan View of Bicycle Warning Added to Existing Crossing

- **Bicycle Warning:** Warns motorists to watch for bicyclists traveling along the roadway with a Bicycle Warning sign (W11-1) and SHARE THE ROAD plaque (W16-1P). The crossing does not have adequate width available to add bike lanes after subtracting the travel way from the clear roadway width and has a speed limit of 40 miles per hour or more. **Figure 4** shows a plan view of an existing crossing with a bicycle warning on each side.

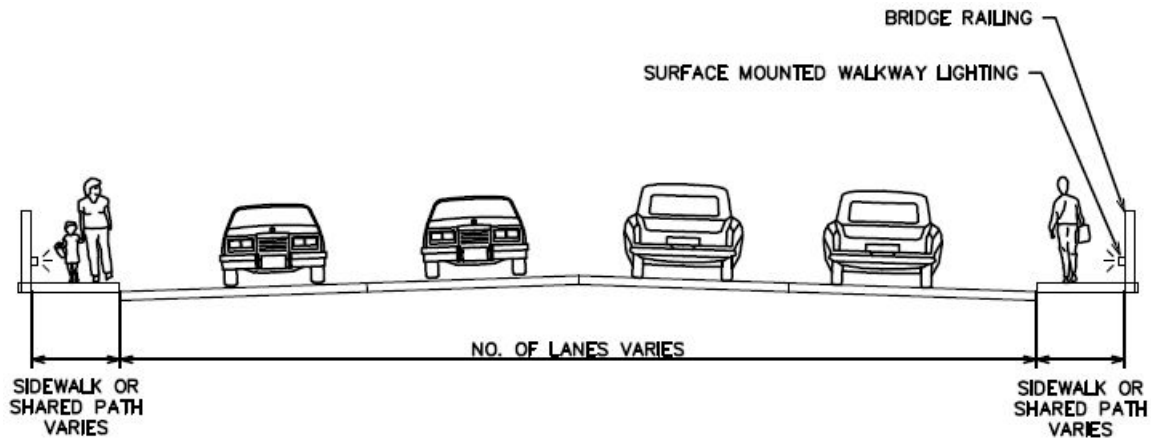
Figure 5: Typical Section of Walkway Lighting Added to Existing Crossing

- **Walkway Lighting:** Increases visibility of non-motorized users at nighttime. **Figure 5** shows a typical section of an existing crossing with surface mounted walkway lighting on each side.
- **Curved Fencing:** Limits the exposure of non-motorized traffic to the freeway. **Figure 6** shows a typical section of an existing crossing with curved fencing on each side.
- **Separation Barrier:** Protects non-motorized users from motorists. **Figure 7** shows a typical section of an existing crossing with a two-foot wide separation barrier on each side.

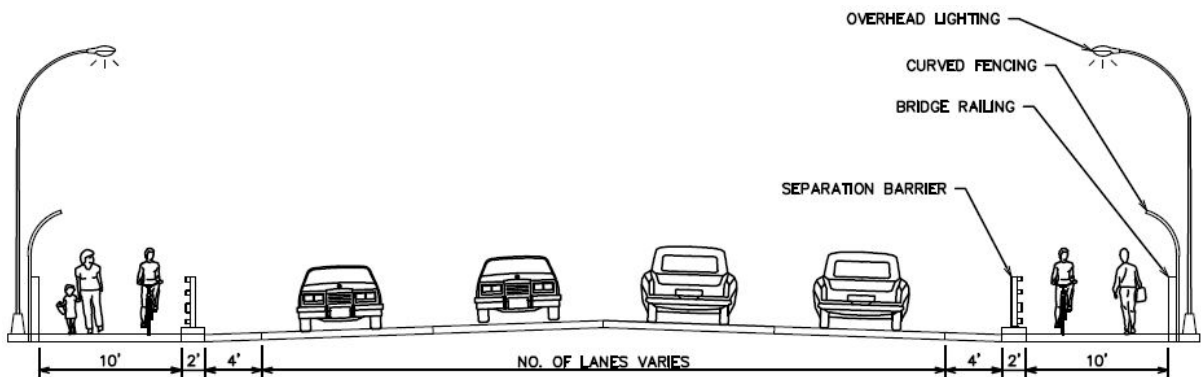
- Shared Path with Separation Barrier, Curved Fencing, and Lighting:** Provides access and separation, limits freeway exposure, and increases nighttime visibility for non-motorized users. **Figure 8** shows a typical section of a crossing with a 10-foot wide shared path, 2-foot wide separation barrier, curved fencing, and overhead lighting.

Source: Adapted from MDOT Bridge Design Guides Section 6.05.02

Reconstructing the bridge to include a shared path with a separation barrier, curved fencing, and overhead lighting on both sides of the crossing costs approximately \$15,000 per linear foot of bridge for two lanes and \$20,400 per linear foot of bridge for four lanes or more. This improvement includes replacing and widening the entire bridge (deck, substructure, superstructure) to include a shared path. If the bridge is in good condition, a shared path may be added by widening the existing crossing without having to reconstruct the entire bridge. If only widening is performed leaving most of the existing bridge in place, the approximate cost is \$4,800 per linear foot of the bridge.

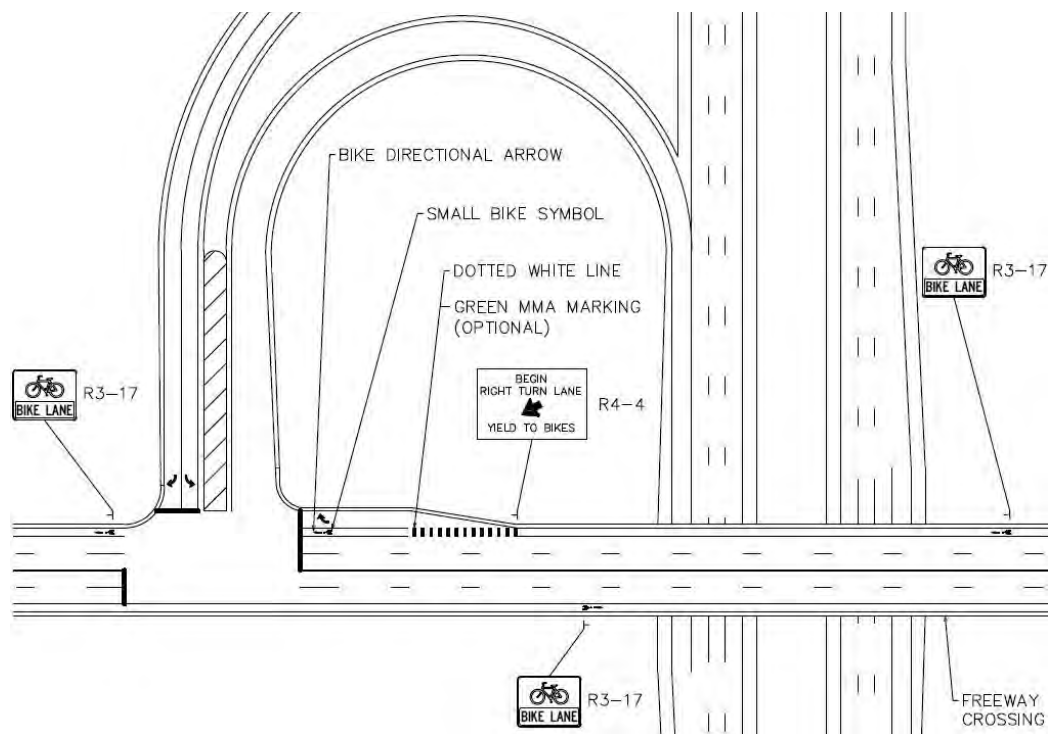
Figure 9: Added Bike Lane at Crossing with Freeway Ramp

The crossing path conflict area between bicyclists and motorists is indicated by a dotted white line, but additional measures can be taken to give road users more warning. A BEGIN RIGHT TURN LANE YIELD TO BIKES (R4-4) sign may be placed at the beginning of the conflict area to inform both motorists and bicyclists of the weaving maneuver. Green Methyl Methacrylate (MMA) pavement markings can also be used to help identify the conflict area. **Figure 9** shows a typical example of how to address an added bike lane at a crossing with a freeway ramp.

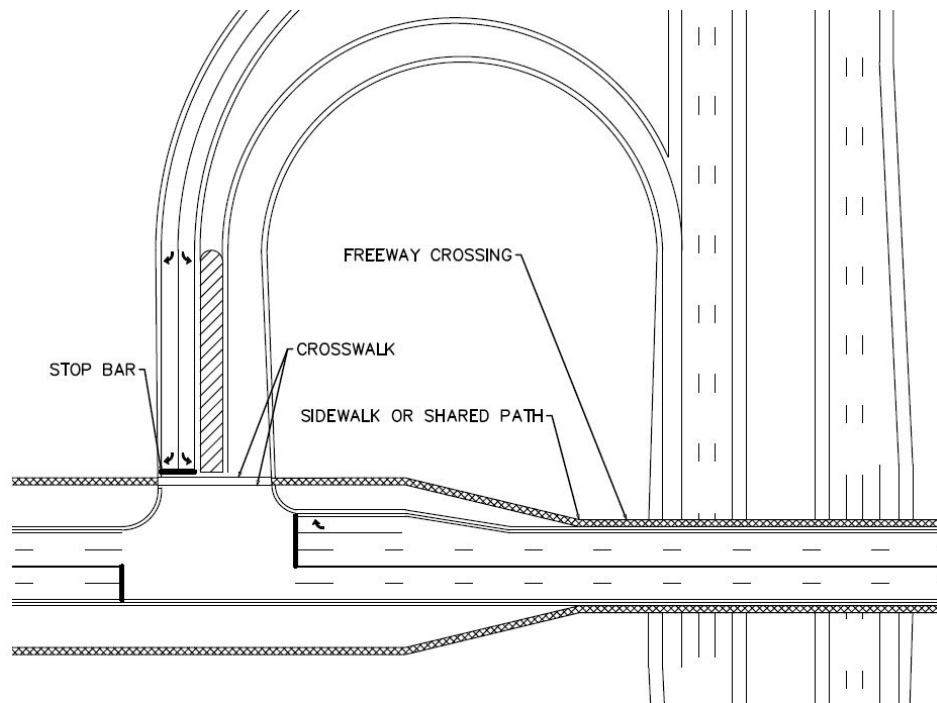
**Figure 10: Added Sidewalk or Shared Path at Crossing with Freeway Ramp**

If any of these challenges are met when designing a sidewalk or shared path across a freeway ramp, it is important to consider possible solutions and apply the basic principles of pedestrian safety. **Figure 10** shows a typical example of how to address an added sidewalk or shared path at a crossing with a freeway ramp.

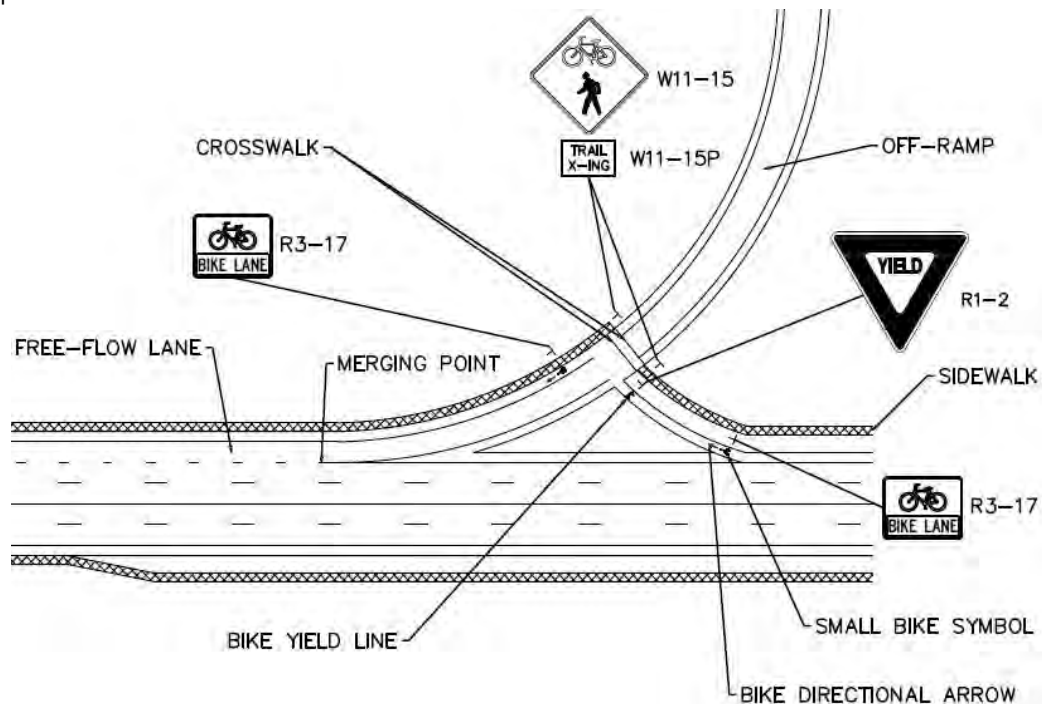
If a bike lane or sidewalk is being added where vehicles are exiting off the ramp in a free-flow movement and the slip lane cannot be eliminated, the trail crossing can be positioned upstream of the merging point. This position allows for non-motorized users to cross at close to a right angle. This trail adjustment increases the visibility for all road users and allows non-motorized users to cross away from where vehicles are trying to merge with traffic. This trail adjustment also provides orderly movement and guidance between road users where bicyclists and pedestrians are to yield to vehicles. **Figure 11** shows a typical treatment of a bike lane and sidewalk crossing a free-flow off-ramp.

Source: Adapted from AASHTO 2012 Guide for the Development of Bicycle Facilities Figure 4-42

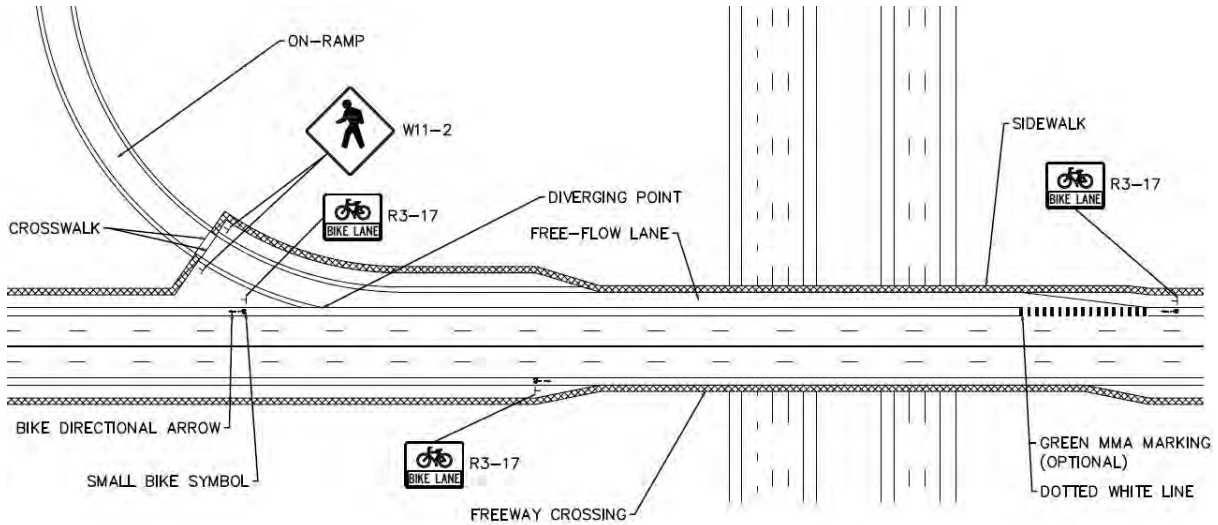
Figure 12: Bike Lane and Sidewalk Crossing Free-Flow On-Ramp

If a bike lane is being added where vehicles are entering onto the ramp in a free-flow movement and the slip lane cannot be eliminated, the bike lane can be shifted to the left of the slip lane in advance of the ramp. This bike lane shift allows for motorists to weave across bicycle traffic away from where vehicles are turning onto the ramp like the bike lane treatment indicated in Section 5.4.1. If a sidewalk is being added, it can be positioned downstream of the diverging point to increase the visibility between motorists and pedestrians. **Figure 12** shows a typical treatment of a bike lane and sidewalk crossing a free-flow on-ramp.

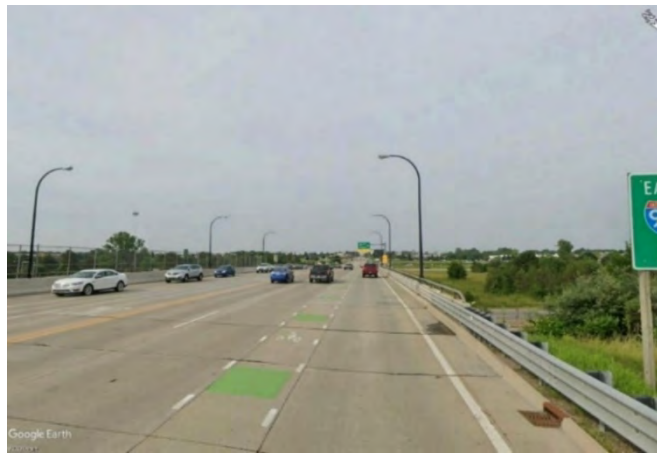
Figure 13: Ann Arbor-Saline Road Crossing I-94 Facing Southwest

Ann Arbor-Saline Road crossing I-94 has an available roadway width of 9.3 feet, assuming 11-foot lanes and a length of 247.9 feet. Non-motorized facilities on this crossing include a northeast-bound sidewalk with a separation barrier and fencing and a bike lane (deduct from available width) and lighting on both sides. Adjacent non-motorized facilities include a northeast-bound sidewalk and a bike lane on both sides that tie into the crossing. **Figure 13** shows a street view of this crossing.

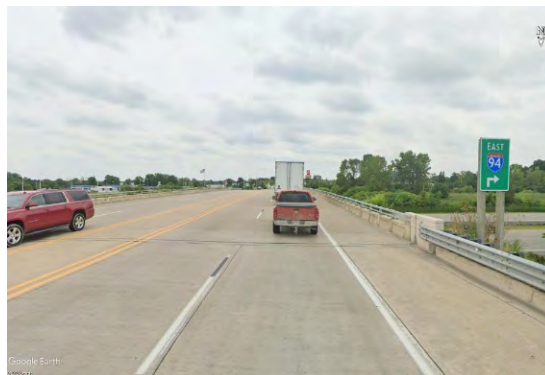
Figure 14: Baker Road Crossing I-94 Facing South

Baker Road crossing I-94 has an available roadway width of 16 feet and a length of 297 feet. There are not any non-motorized facilities on or adjacent to this crossing. **Figure 14** shows a street view of this crossing.

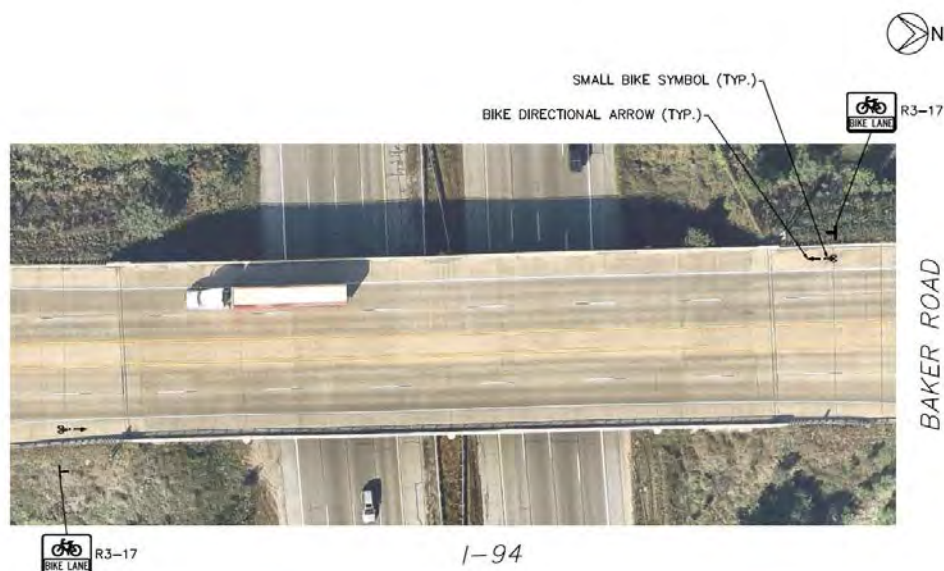
Figure 15: Proposed Bike Lanes at Baker Road Crossing I-94

A six-foot bike lane could be added on both sides of the crossing, which would cost approximately \$3,000. **Figure 15** shows a concept of the proposed bike lanes at this crossing.

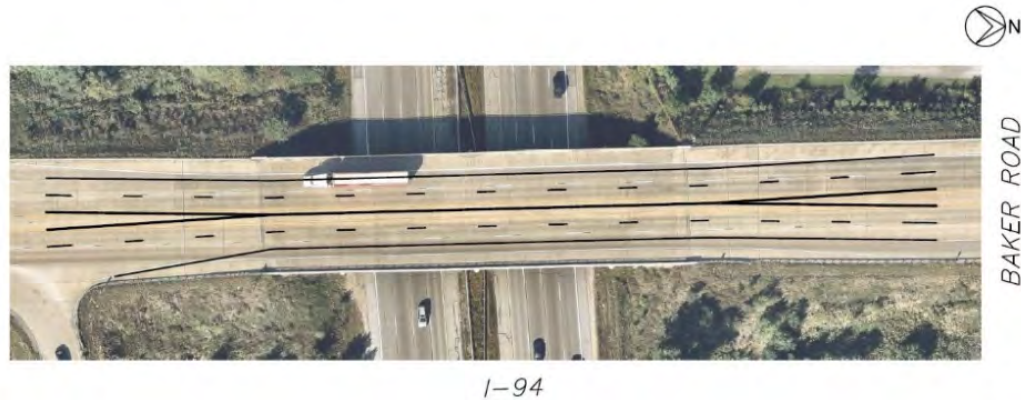
**Figure 16: Proposed Lane Geometry at Baker Road Crossing I-94**

If the center left-turn lane were removed, a shared path with a separation barrier, curved fencing, and lighting could be added on both sides of the crossing, which would cost approximately \$390,000. **Figure 16** shows a concept of the proposed lane geometry without the center left-turn lane and refer to **Figure 8** for a typical section of a crossing with a shared path.

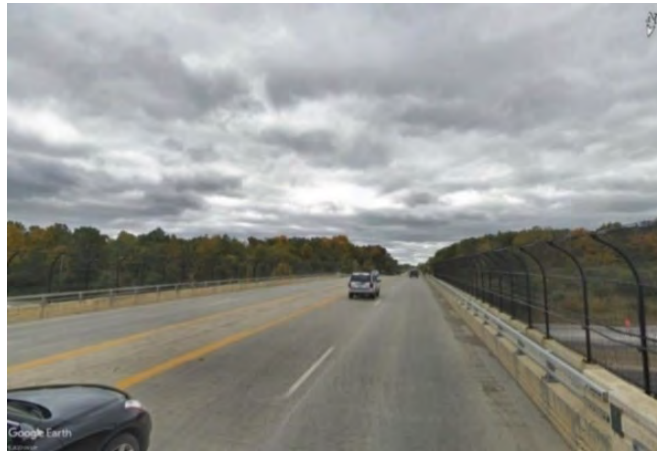
**Figure 17: Carpenter Road Crossing I-94 Facing South**

Carpenter Road crossing I-94 has an available roadway width of 12 feet, if the center lane were to be removed, and a length of 289.5 feet. Non-motorized facilities on this crossing include a sidewalk with a separation barrier and fencing on both sides. Adjacent non-motorized facilities include a southbound sidewalk that ties into the crossing and a bike lane on both sides south of the crossing. **Figure 17** shows a street view of this crossing.

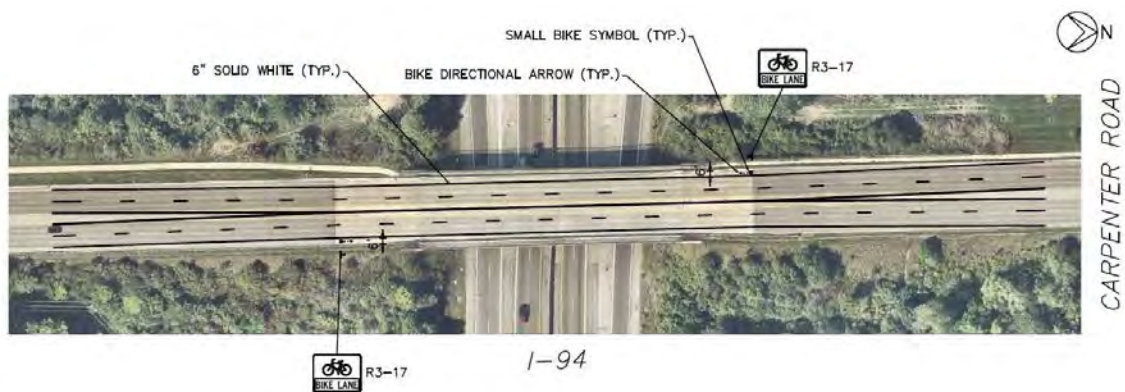
**Figure 18: Proposed Bike Lanes and New Lane Geometry at Carpenter Road Crossing I-94**

If the center left-turn lane were removed, a six-foot bike lane would be available on both sides of the crossing, which would cost approximately \$3,000. **Figure 18** shows a concept of the proposed bike lanes and new lane geometry without the center lane at this crossing.

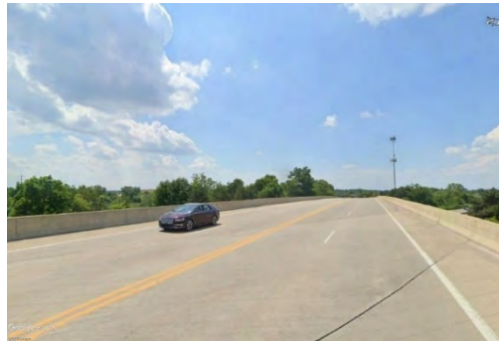
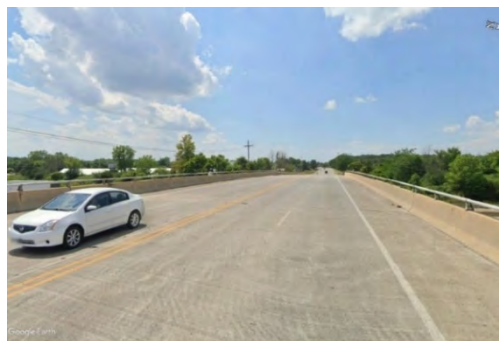
Ellsworth Road crossing I-94 and US-23 has available roadway widths of 12 and 9 feet, respectively, and lengths of 599.3 and 304.6 feet, respectively. Non-motorized facilities on these crossings include bike lanes (deduct from available width) on both sides. Adjacent non-motorized facilities include bike lanes on both sides that tie into the crossings. **Figures 19** and **20** show a street view of these crossings, respectively.

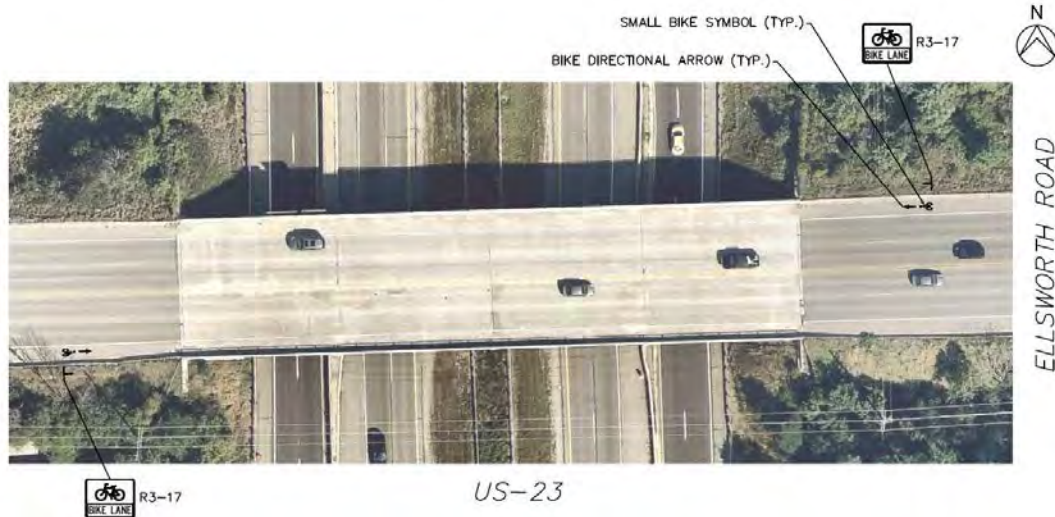
Figure 21: Proposed Bicycle Signs and Pavement Markings at Ellsworth Road Crossing I-94

A BIKE LANE sign and bicycle lane symbol marking with an arrow could be added in advance of each crossing on both sides, which would cost approximately \$500. **Figure 21** shows a concept of the proposed bicycle signs and pavement markings at Ellsworth Road crossing US-23. Ellsworth Road crossing I-94 would be similar.

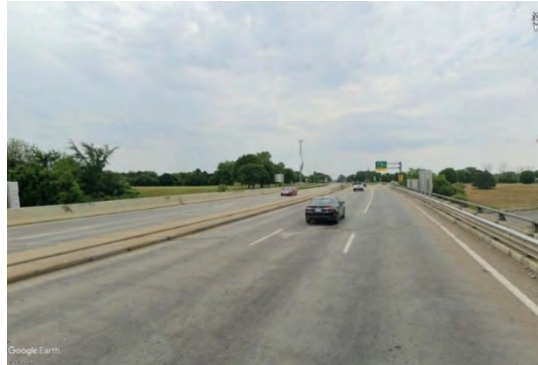
**Figure 22: Huron/Hamilton Street Crossing I-94 Facing South**

Huron/Hamilton Street crossing I-94 has an available roadway width of 7.5 feet and a length of 294.7 feet. There are not any non-motorized facilities on this crossing. Adjacent non-motorized facilities include a southbound sidewalk that ends in advance of the crossing. **Figure 22** shows a street view of this crossing.

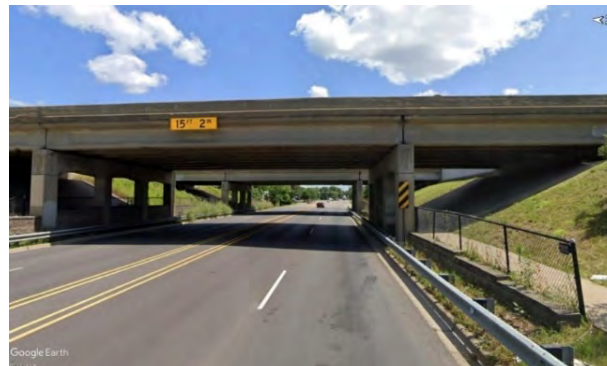
**Figure 23: Packard Street Crossing US-23 Facing East**

Packard Street crossing US-23 is an underpass. Non-motorized facilities at this crossing include a sidewalk with a separation barrier and fencing on both sides. Adjacent non-motorized facilities include a sidewalk on both sides underneath the crossing. **Figure 23** shows a street view of this crossing.

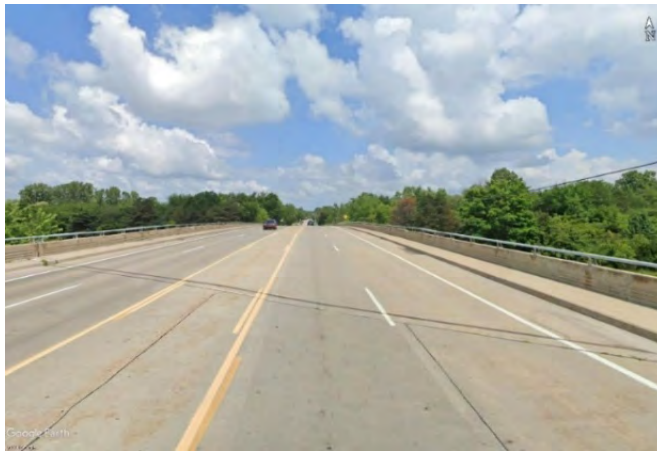
**Figure 24: Platt Road Crossing I-94 Facing South**

Platt Road crossing I-94 has an available roadway width of 11 feet, assuming 11-foot lanes and a 9-foot center lane, and a length of 315.6 feet. Non-motorized facilities on this crossing include a sidewalk and bike lane (deduct from available width) on both sides. Adjacent non-motorized facilities include a sidewalk and bike lane on both sides that tie into the crossing. **Figure 24** shows a street view of this crossing.

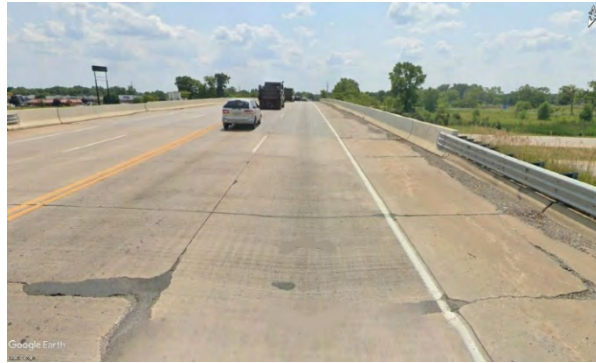
Figure 25: Rawsonville Road Crossing I-94 Facing South

Rawsonville Road crossing I-94 has an available roadway width of 17.9 feet and a length of 312.8 feet. There are not any non-motorized facilities on or adjacent to this crossing. **Figure 25** shows a street view of this crossing.

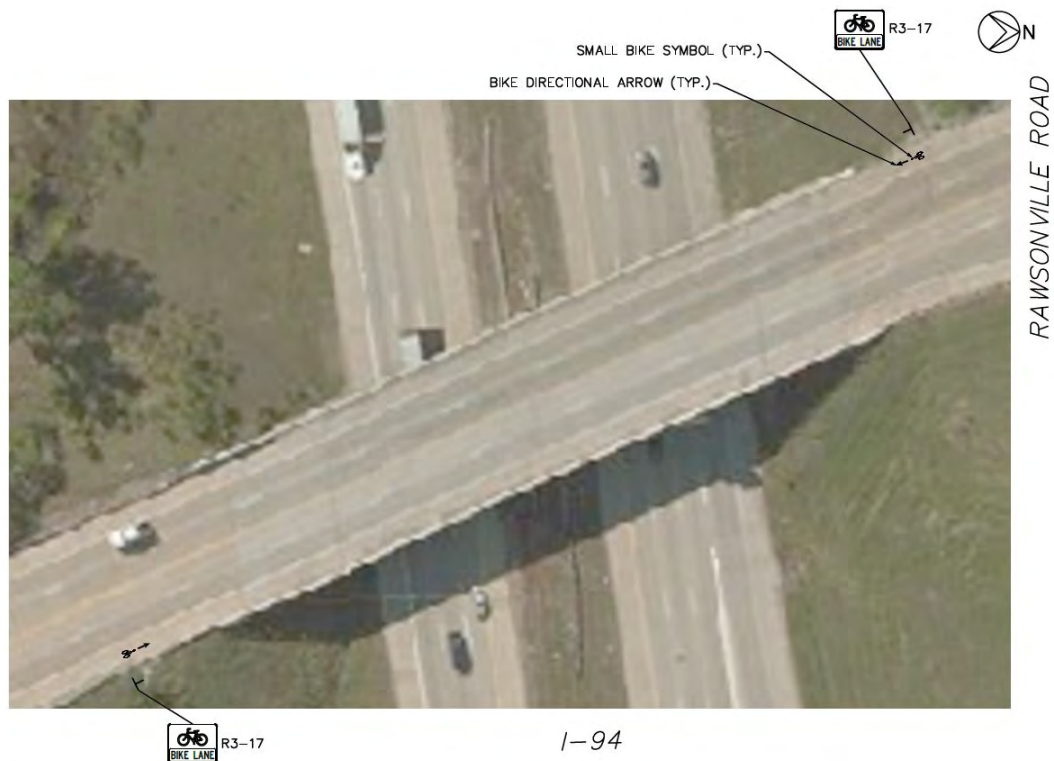
Figure 26: Proposed Bike Lanes at Rawsonville Road Crossing I-94

A six-foot bicycle lane could be added on both sides of the crossing, which would cost approximately \$3,000. **Figure 26** shows a concept of the proposed bike lanes at this crossing.

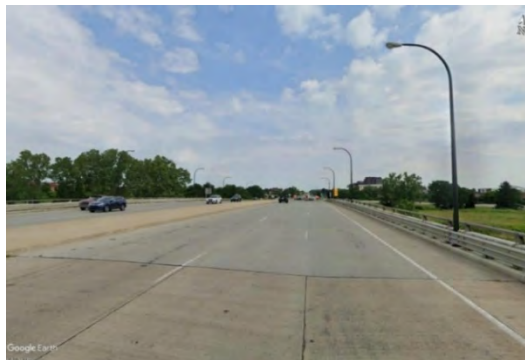
**Figure 27: State Street Crossing I-94 Facing North**

State Street crossing I-94 has an available roadway width of 41.8 feet and a length of 232 feet. Non-motorized facilities on this crossing include overhead lighting on both sides. Adjacent non-motorized facilities include sidewalks on both sides that end in advance of the crossing. **Figure 27** shows a street view of this crossing.

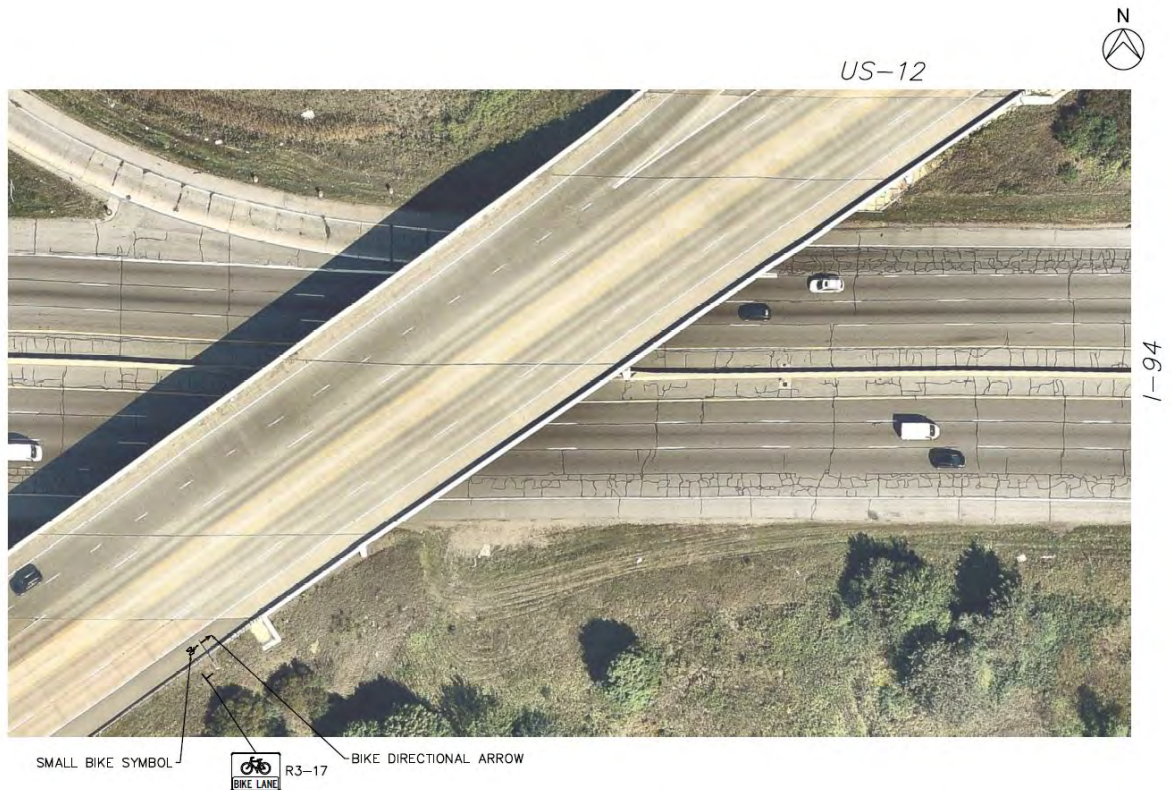
**Figure 29: Proposed Northeast-Bound Bike Lane at US-12 Crossing I-94**

A six-foot northeast-bound bike lane could be added, which would cost approximately \$3,000. **Figure 29** shows a concept of the proposed northeast-bound bike lane at this crossing.

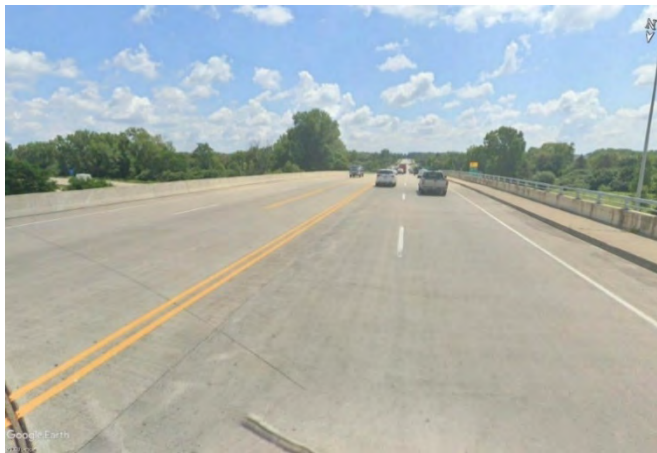
**Figure 30: Zeeb Road Crossing I-94 Facing South**

Zeeb Road crossing I-94 has an available roadway width of 14.4 feet and a length of 346.9 feet. Non-motorized facilities on this crossing include a southbound sidewalk. Adjacent non-motorized facilities include a southbound sidewalk that ties into the crossing and a northbound sidewalk (north of crossing) that ends in advance of the crossing. **Figure 30** shows a street view of this crossing.

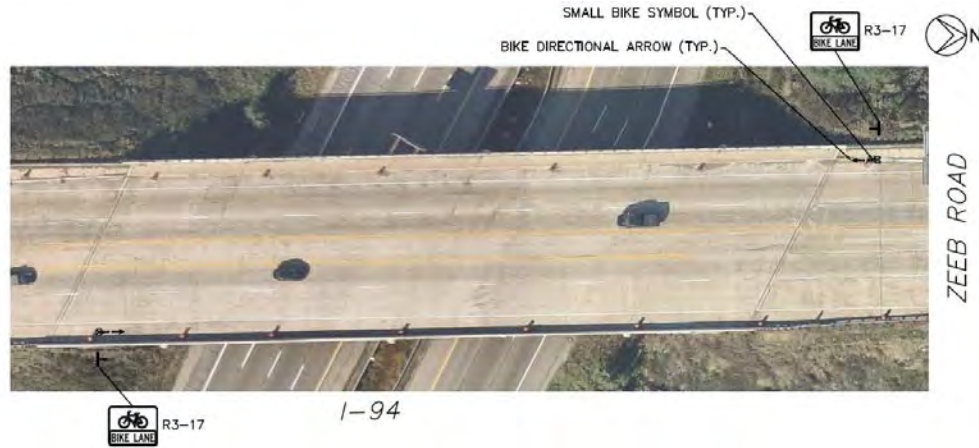
**Figure 31: Proposed Bike Lanes at Zeeb Road Crossing I-94**

A six-foot bike lane could be added on both sides of the crossing, which would cost approximately \$3,000. **Figure 31** shows a concept of the proposed bike lanes at this crossing.

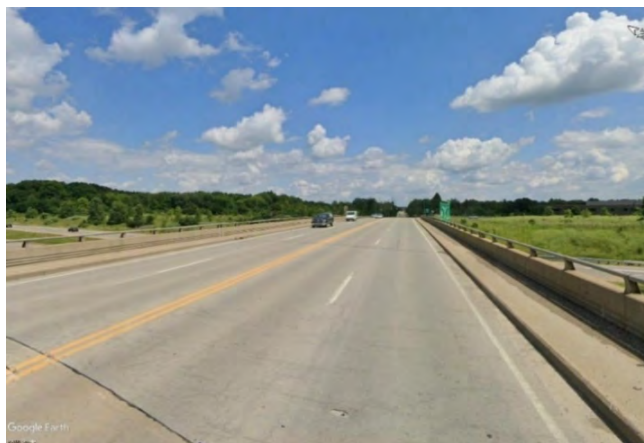
**Figure 32: Plymouth Road Crossing US-23 Facing Northeast**

Plymouth Road crossing US-23 has an available roadway width of only 4.3 feet and a length of 348.5 feet. Non-motorized facilities on this crossing include sidewalk on both sides. Adjacent non-motorized facilities include an eastbound sidewalk that ends in advance of the crossing. **Figure 32** shows a street view of this crossing.

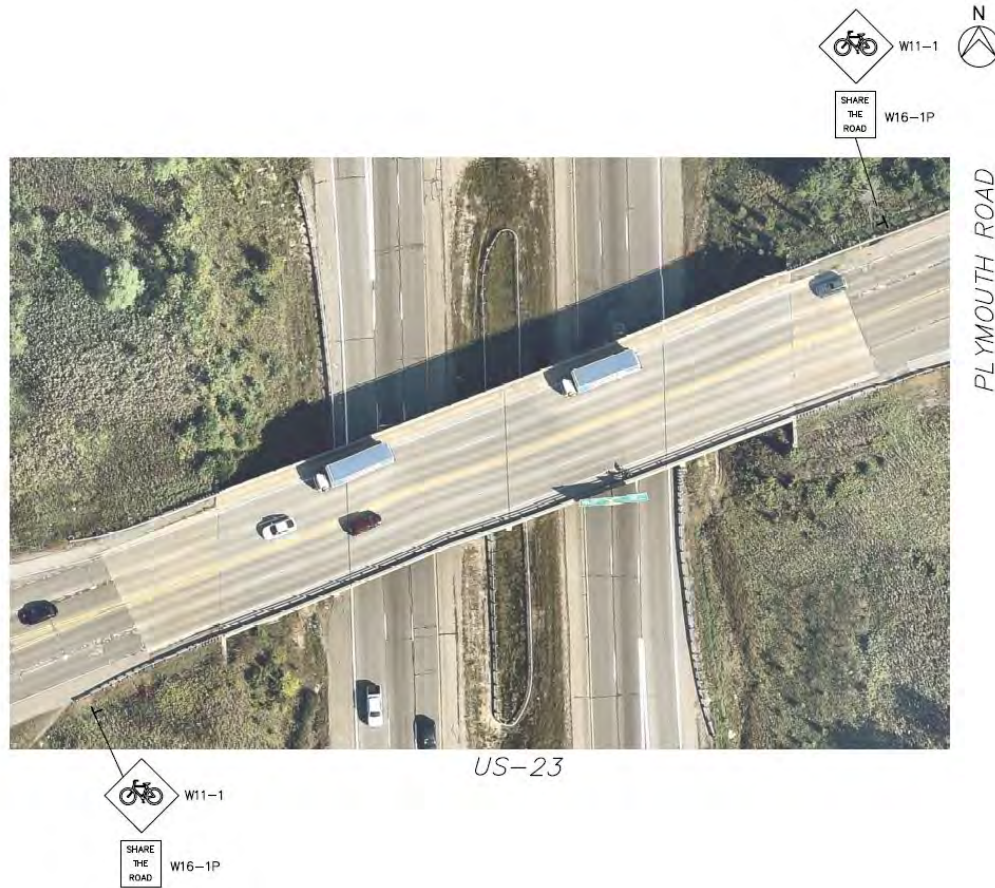
**Figure 33: Proposed Bicycle Warning Signs and Plaques at Plymouth Road Crossing US-23**

A Bicycle Warning sign and SHARE THE ROAD plaque could be added in advance of each crossing on both sides, which would cost approximately \$500. **Figure 33** shows a concept of the proposed bicycle warning signs and plaques at this crossing.

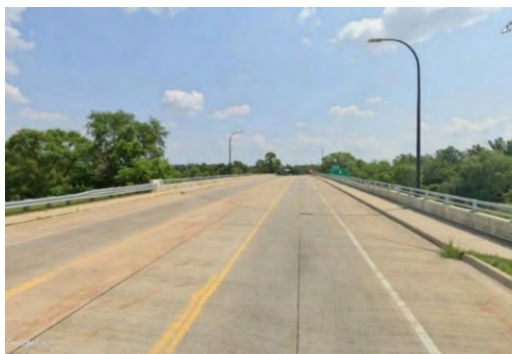
**Figure 34: Grove Street Crossing I-94 Facing Southeast**

Grove Street crossing I-94 has an available roadway width of 16 feet and a length of 453.3 feet. Non-motorized facilities on this crossing include a sidewalk, bike lanes (deduct from available width), and lighting on both sides. Adjacent non-motorized facilities include a sidewalk and bike lane on both sides that tie into the crossing. **Figure 34** shows a street view of this crossing.

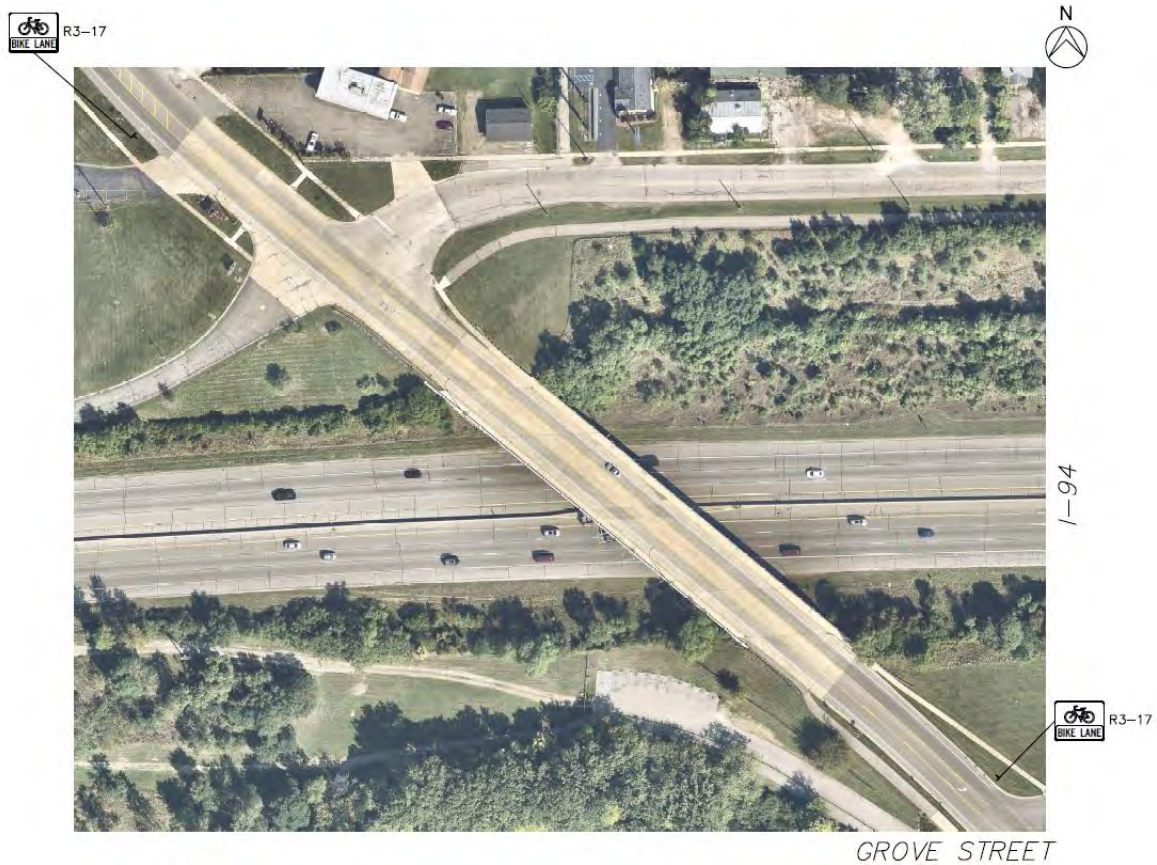
Figure 35: Proposed Bicycle Signs at Grove Street Crossing I-94

A BIKE LANE sign could be added at the existing bicycle pavement markings in advance of each crossing on both sides, which would cost approximately \$500. **Figure 35** shows a concept of the proposed bicycle signs at this crossing.

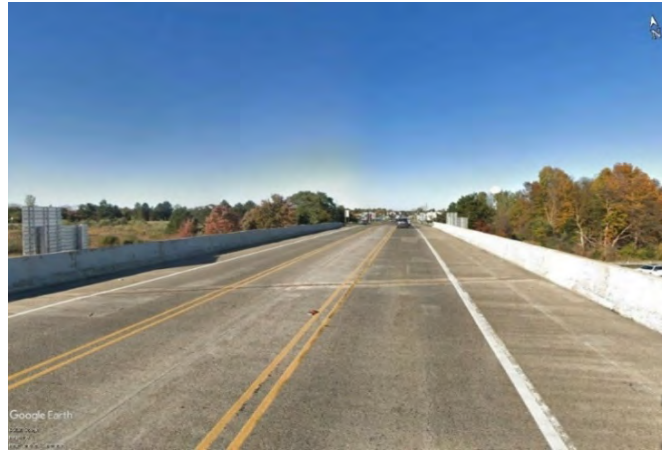
Figure 36: Main Street/Chelsea Manchester Road Crossing I-94 Facing North

Main Street/Chelsea Manchester Road crossing I-94 has an available roadway width of 16.8 feet and a length of 250 feet. There are not any non-motorized facilities on or adjacent to this crossing. **Figure 36** shows a street view of this crossing.

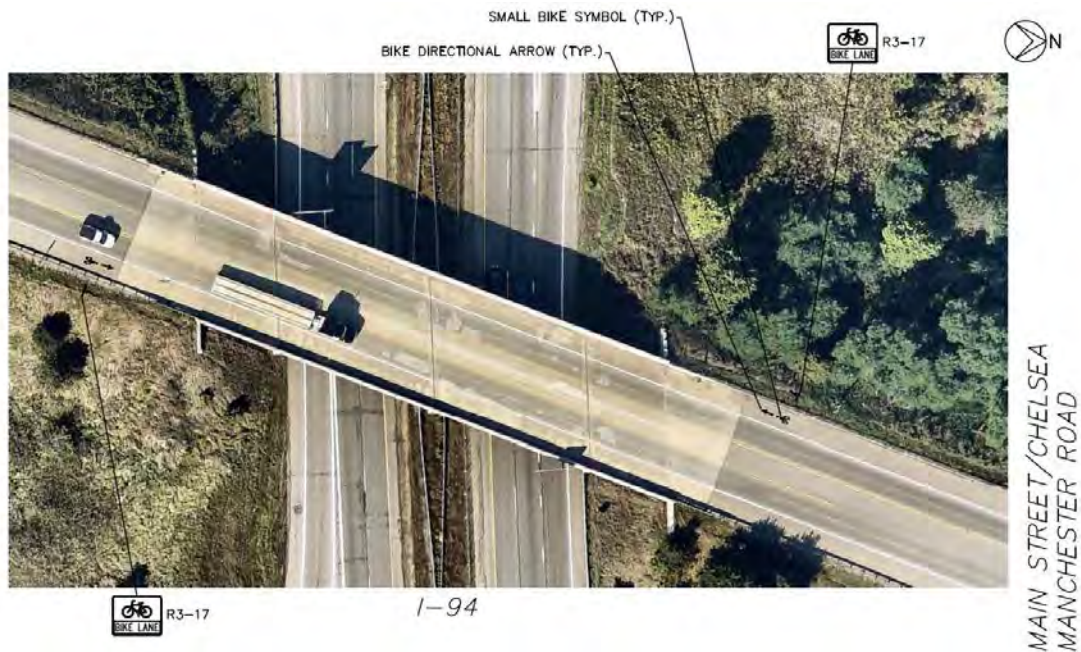
Figure 37: Proposed Bike Lanes at Main Street/Chelsea Manchester Road Crossing I-94

A six-foot bike lane could be added on both sides of the crossing, which would cost approximately \$3,000. **Figure 37** shows a concept of the proposed bike lanes at this crossing.

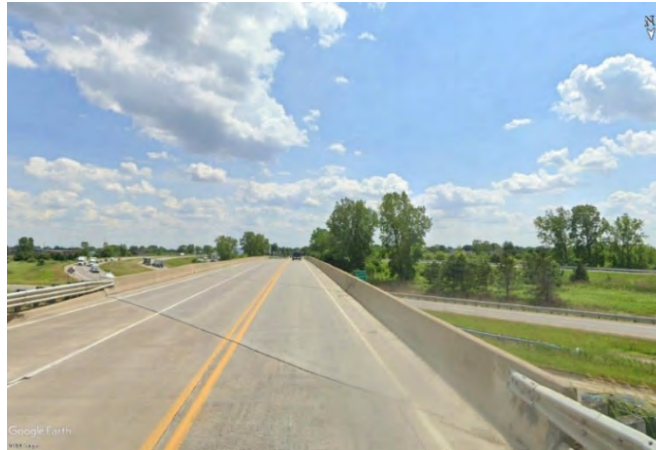
**Figure 38: Carpenter Road Crossing US-23 Facing South**

Carpenter Road crossing US-23 has an available roadway width of only 4 feet and a length of 373.3 feet. There are not any non-motorized facilities on or adjacent to this crossing. **Figure 38** shows a street view of this crossing.

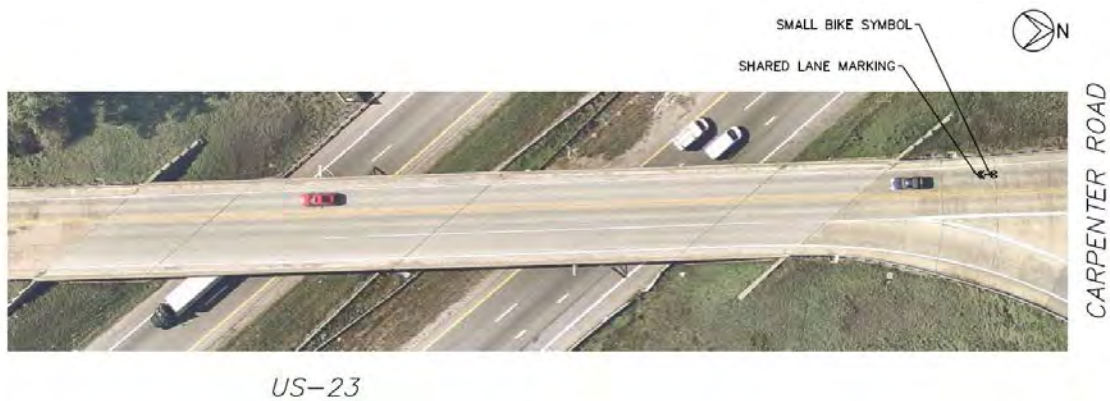
**Figure 39: Proposed Shared Lane at Carpenter Road Crossing US-23**

A southbound shared lane could be added, which would cost approximately \$2,500. **Figure 39** shows a concept of the proposed shared lane on the crossing.
