# FREEWAY CROSSING NON-MOTORIZED RETROFIT

FOR WASHTENAW AREA TRANSPORTATION STUDY

Final Report: June 30, 2020  
HRC Job No. 20191021

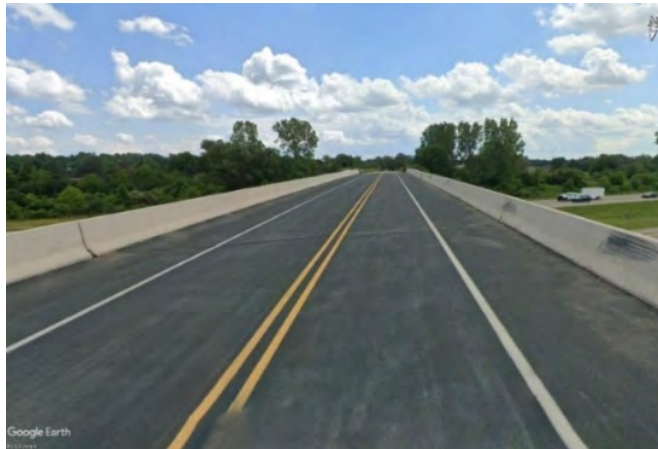
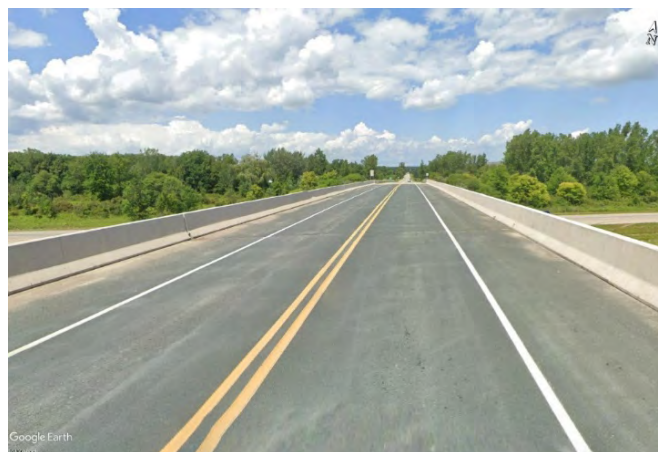
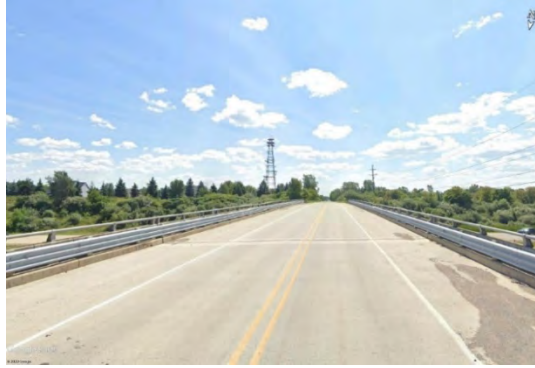
Curtis, Gotfredson, and Napier Roads crossing M-14 and North Territorial Road crossing US-23 have available roadway widths ranging from 13.7 to 16.3 feet and lengths ranging from 189.9 to 343.9 feet. There are not any non-motorized facilities on or adjacent to these crossings. **Figures 40 – 43** show a street view of these crossings.

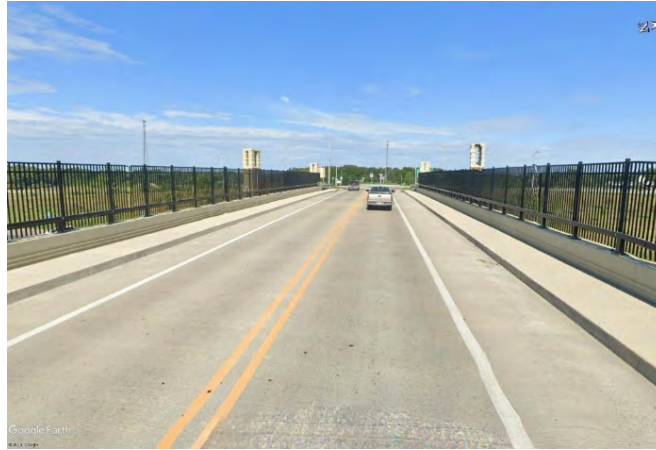
Figure 45: Eight Mile Road Crossing US-23 Facing West

Eight Mile Road crossing US-23 has an available roadway width of 10 feet and a length of 244.2 feet. Non-motorized facilities on this crossing include a sidewalk and fencing on both sides. There are not any non-motorized facilities adjacent to this crossing. **Figure 45** shows a street view of this crossing.

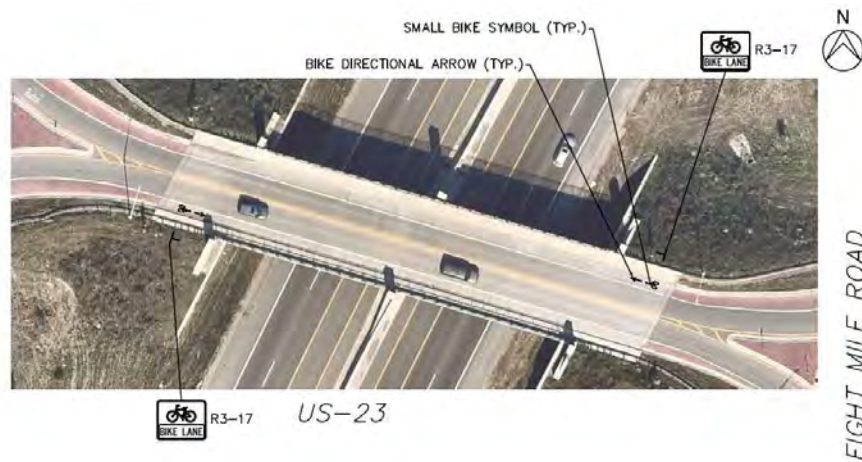
Figure 46: Proposed Bike Lanes at Eight Mile Road Crossing US-23

A five-foot bike lane could be added on both sides of the crossing, which would cost approximately \$3,000. **Figure 46** shows a concept of the proposed bike lanes at this crossing.

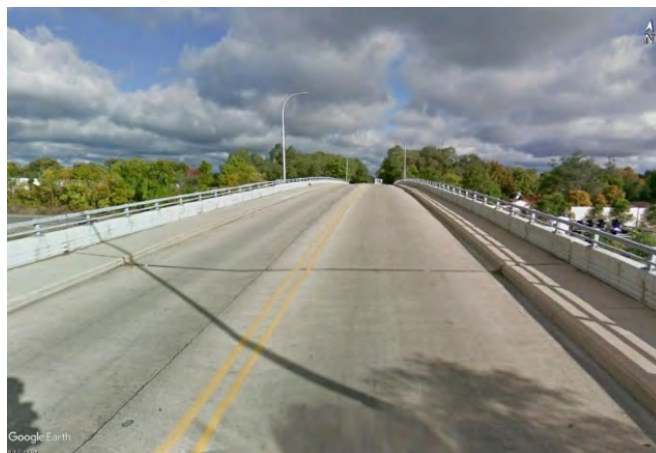
**Figure 47: Harris Road Crossing I-94 Facing North**

Harris Road crossing I-94 has an available roadway width of 11.8 feet, if the lane widths are reduced to 11 feet, and a length of 534.8 feet. Non-motorized facilities on this crossing include a sidewalk and lighting on both sides. Adjacent non-motorized facilities include a sidewalk on both sides that tie into the crossing. **Figure 47** shows a street view of this crossing.

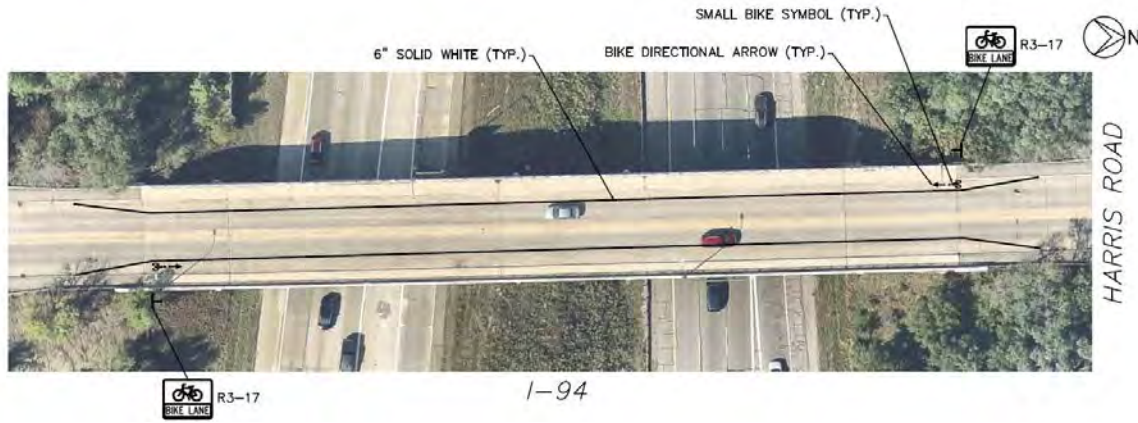
**Figure 48: Proposed Bike Lanes at Harris Road Crossing I-94**

If the lane widths were reduced to 11 feet, a 5.9-foot bike lane could be added on both sides of the crossing, which would cost approximately \$3,000. **Figure 48** shows a concept of the proposed bike lanes at this crossing.

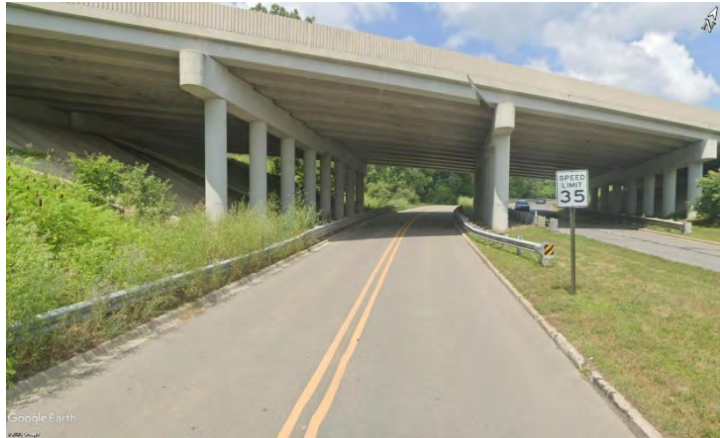
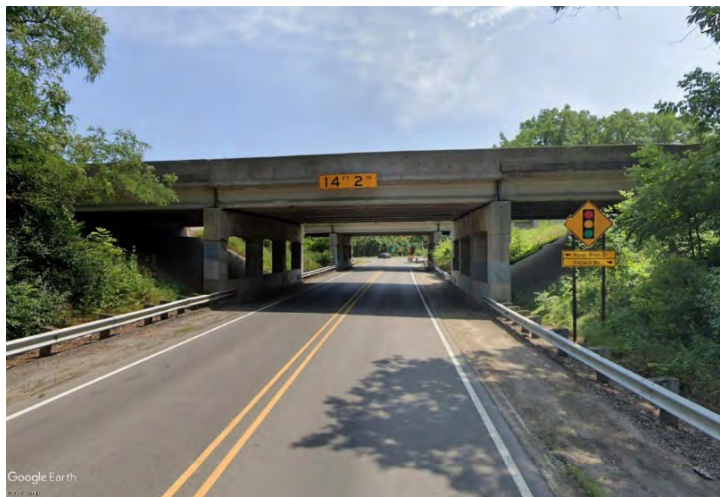
Huron River Drive crossing M-14 and US-23 are underpasses. There are not any non-motorized facilities on or adjacent to these crossings. **Figures 49** and **50** show a street view of these crossings, respectively.

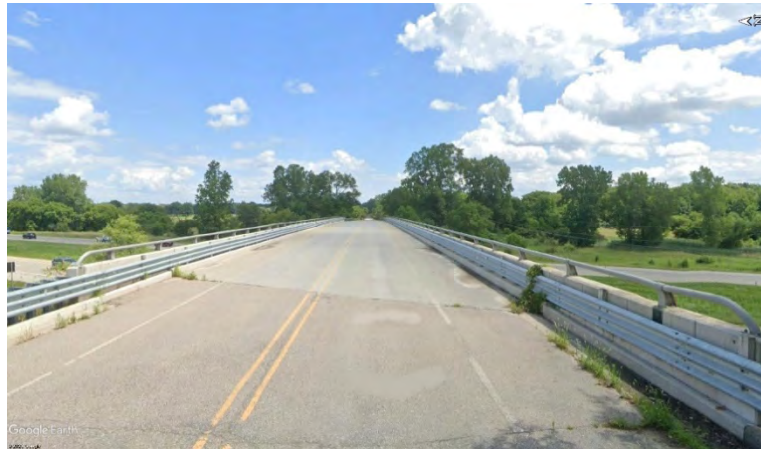
Figure 51: Street View of Joy Road Crossing M-14 Facing East

Joy Road crossing M-14 has an available roadway width of 10.5 feet, if the lane widths are reduced to 11 feet, and a length of 358.6 feet. There are not any non-motorized facilities on or adjacent to this crossing. **Figure 51** shows a street view of this crossing.

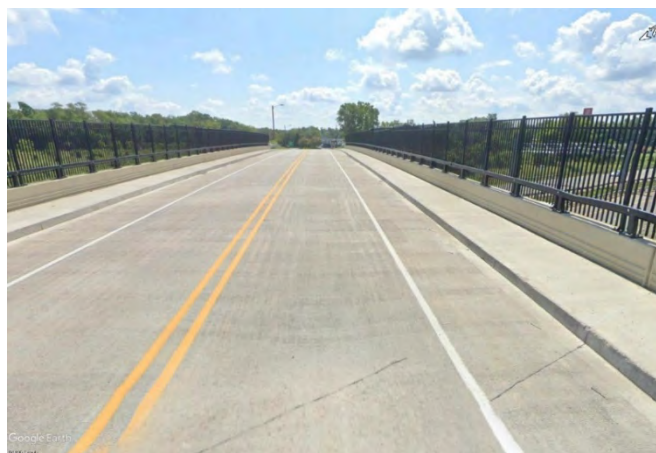
**Figure 53: Six Mile Road Crossing US-23 Facing Southeast**

Six Mile Road crossing US-23 has an available roadway width of 10 feet and a length of 275 feet. Non-motorized facilities on this crossing include a sidewalk, fencing, and a bike lane (deduct from available width) on both sides. Adjacent non-motorized facilities include a northwest-bound bike lane that ties into the crossing and a paved area on both sides that tie into the southeast end of the crossing. **Figure 53** shows a street view of this crossing.

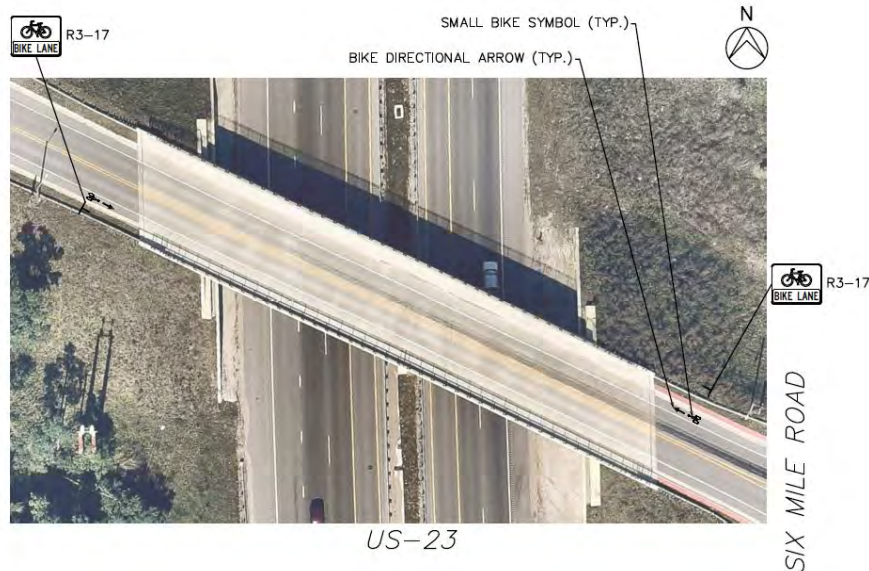
Figure 54: Proposed Bicycle Signs and Pavement Markings at Six Mile Road Crossing US-23

A BIKE LANE sign and bicycle lane symbol marking with an arrow could be added in advance of the crossing on both sides, which would cost approximately \$3,000. **Figure 54** shows a concept of the proposed bicycle signs and pavement markings this crossing.

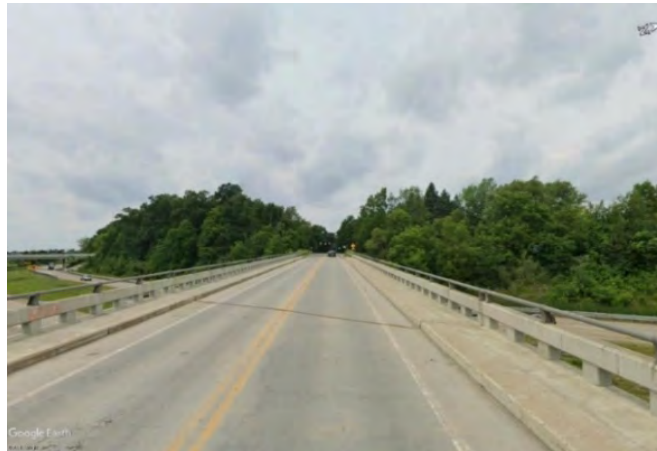
Figure 68: Dexter/Dexter Ann Arbor Road Crossing M-14 Facing Northwest

Dexter Road/Dexter Ann Arbor Road crossing M-14 has an available roadway width of only 5.9 feet and a length of 362 feet. Non-motorized facilities on this crossing include a sidewalk on both sides. Adjacent non-motorized facilities include an eastbound sidewalk that ties into the east end of the crossing. **Figure 68** shows a street view of the crossing.

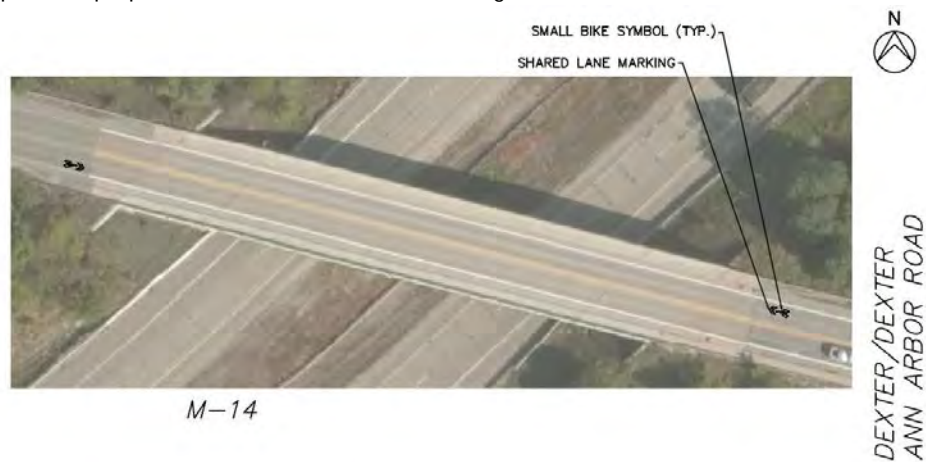
Figure 69: Proposed Shared Lanes at Dexter/Dexter Ann Arbor Road Crossing M-14

Shared lanes could be added on both sides of the crossing, which would cost approximately \$2,500. **Figure 69** shows a concept of the proposed shared lanes at this crossing.

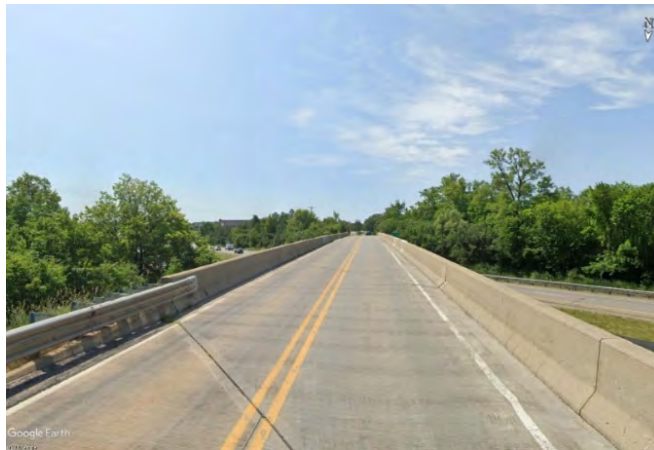
**Figure 70: Earhart Road Crossing US-23 Facing South**

Earhart and Nixon Road crossing US-23 have available roadway widths of 1.5 feet or less and lengths of 365.4 and 233.5 feet, respectively. There are not any non-motorized facilities on or adjacent to these crossings. **Figures 70 and 71** show a street view of these crossings, respectively.

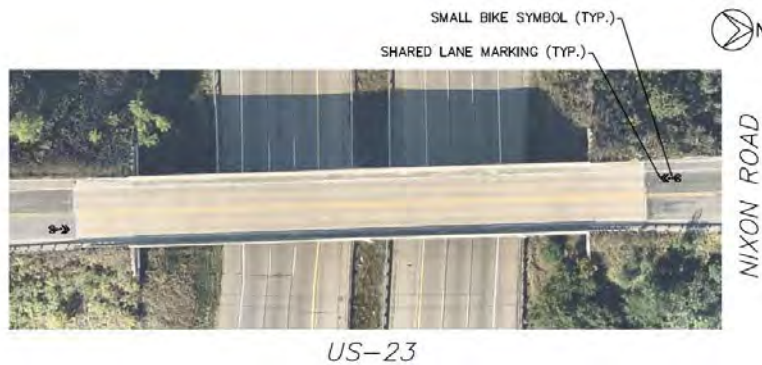
Figure 72: Proposed Shared Lanes at Nixon Road Crossing US-23

Shared lanes could be added on both sides of the crossing, which would cost approximately \$2,500. **Figure 72** shows a concept of the proposed shared lanes at Nixon Road Crossing US-23. The concept for Earhart Road crossing US-23 would be similar.

- With bridge condition ratings of five and six, preventative maintenance is expected to be performed. The shared lanes could be coordinated during this time.
- A reduced shared path width of eight feet may be suitable for Nixon Road since the area is more rural.

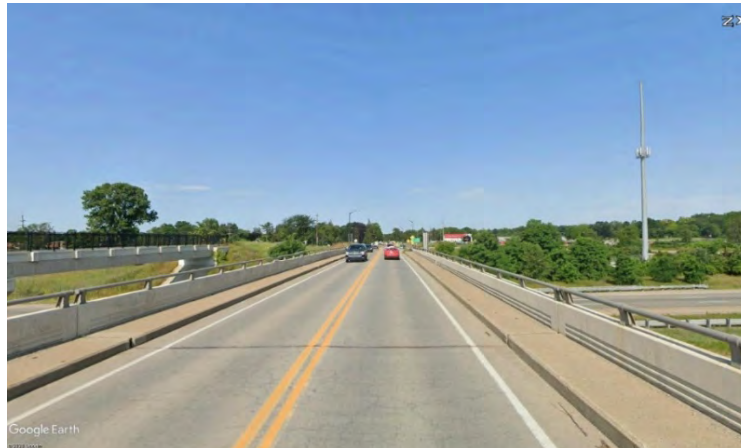
Figure 73: Geddes Road Crossing US-23 Facing West

Geddes Road crossing US-23 has an available roadway width of only 4 feet and a length of 319.4 feet. Non-motorized facilities near this crossing include an eastbound shared path bridge with fencing. Adjacent non-motorized facilities include an eastbound shared path that ties into the crossing. **Figure 73** shows a street view at this crossing.

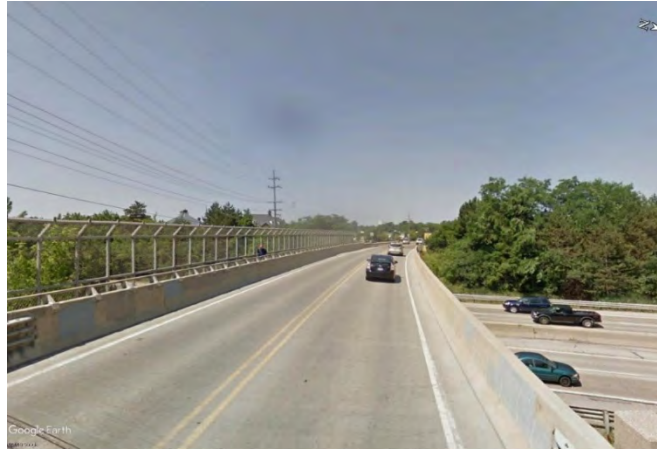
Figure 74: Liberty Road Crossing I-94 Facing West

Liberty Road crossing I-94 does not have any available roadway width and has a length of 226 feet. Non-motorized facilities on this crossing include an eastbound sidewalk with a separation barrier and fencing. Adjacent non-motorized facilities include an eastbound sidewalk that ties into the crossing, a westbound sidewalk that ends in advance of the crossing, and a bike lane on both sides that end in advance of the crosswalk. **Figure 74** shows a street view of this crossing.

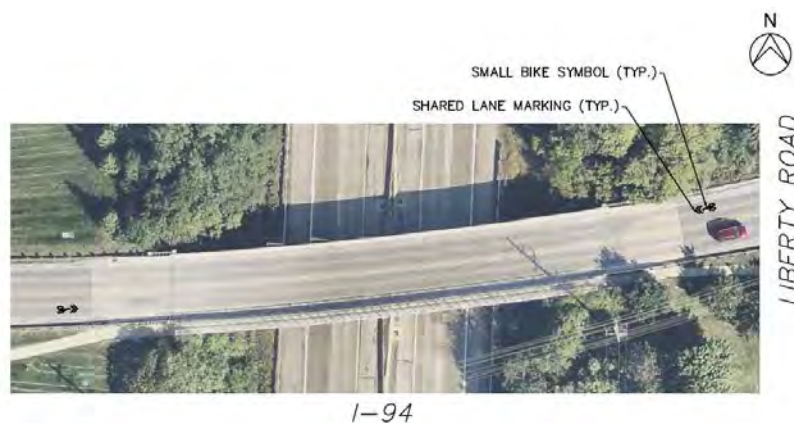
Figure 75: Proposed Shared Lanes at Liberty Road Crossing I-94

Shared lanes could be added on both sides of the crossing, which would cost approximately \$2,500. **Figure 75** shows a concept of the proposed shared lanes on the crossing.

- With a bridge condition rating of five, preventative maintenance is expected to be performed. The shared lanes could be coordinated during this time.
- Portions of the eastbound sidewalk with separation barrier and fencing may be salvageable if converted into a shared path.

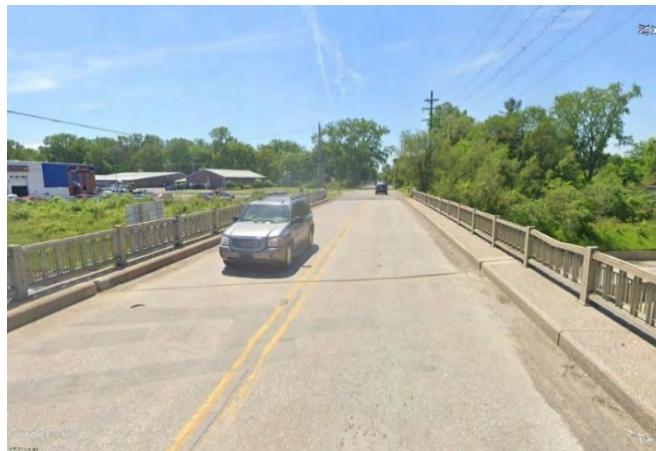
**Figure 76: Milan-Oakville Road/County Street Crossing US-23 Facing West**

Milan-Oakville Road/County Street crossing US-23 has an available roadway width of only 3.9 feet and a length of 174.8 feet. Non-motorized facilities on this crossing include a westbound sidewalk. Adjacent non-motorized facilities include a westbound sidewalk that ties into the crossing. **Figure 76** shows a street view of this crossing.

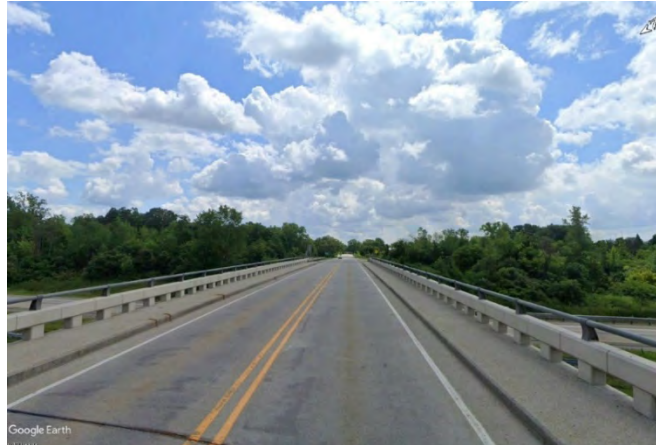
Figure 78: Miller Road Crossing M-14 Facing Southeast

Miller Road crossing M-14 has an available roadway width of only 4.5 feet and a length of 325.1 feet. Non-motorized facilities on this crossing include a sidewalk on both sides. Adjacent non-motorized facilities include a southeast-bound sidewalk that ends in advance of the northwest end of the crossing. **Figure 78** shows a street view of this crossing.

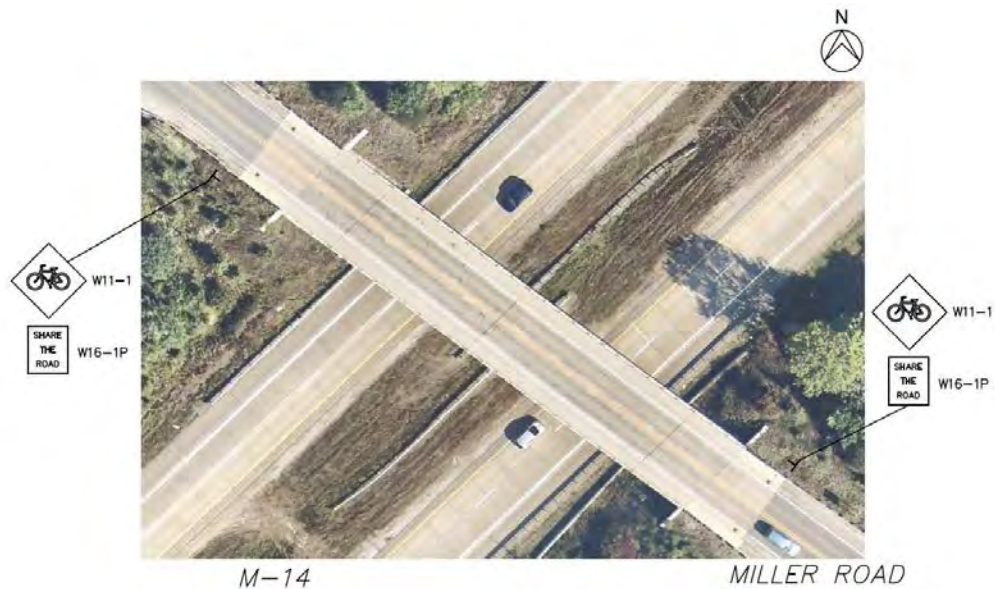
Figure 79: Proposed Bicycle Warning Signs and Plaques at Miller Road Crossing M-14

A Bicycle Warning sign with a SHARE THE ROAD plaque could be added in advance of the crossing on both sides, which would cost approximately \$500. **Figure 79** shows a concept of the proposed bicycle warning signs and plaques at this crossing.

- With a bridge condition rating of four, rehabilitation is expected to be performed. The bicycle warning signs, plaques, curved fencing, and walkway lighting could be coordinated during this time.
- The posted speed limit is 50 miles per hour. Shared lanes are not recommended for roadways having a speed limit above 35 miles per hour.
- On-ramps and off-ramps exist in advance of the crossing. Refer to Section 5.4.2 for guidance on shared paths at freeway ramps.

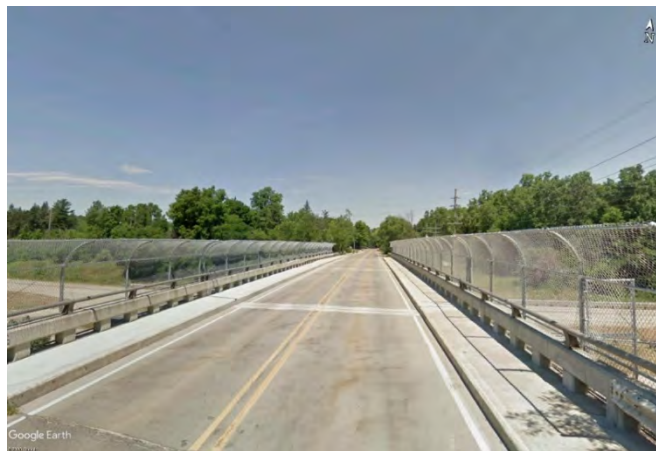
**Figure 80: Newport Road Crossing M-14 Facing North**

Newport Road crossing M-14 has an available roadway width of only 2 feet and a length of 314.6 feet. Non-motorized facilities on this crossing include a sidewalk and fencing on both sides and a northbound Bicycle Warning sign with a SHARE THE ROAD plaque. Adjacent non-motorized facilities include a southbound sidewalk that ties into the crossing, a southbound shared lane south of the crossing, and a northbound bike lane that ends in advance of the crossing. **Figure 80** shows a street view of the crossing.

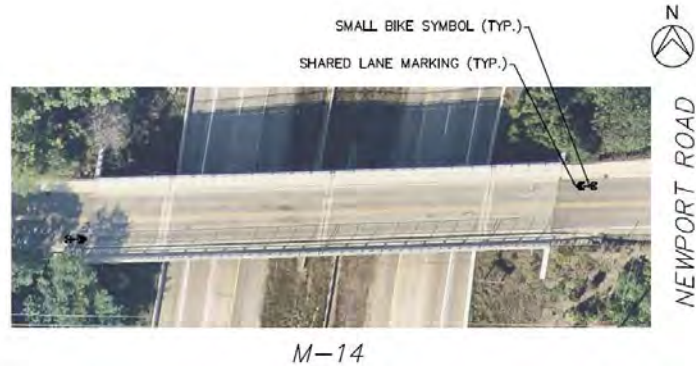
**Figure 81: Proposed Shared Lanes at Newport Road Crossing M-14**

A shared lane could be added on both sides of the crossing, which would cost approximately \$2,500. **Figure 81** shows a concept of the proposed shared lanes on this crossing.

- With a bridge condition rating of six, preventative maintenance is expected to be performed. The shared lanes could be coordinated during this time.
- The northbound Bicycle Warning sign and SHARE THE ROAD plaque should be removed if shared lanes are added.

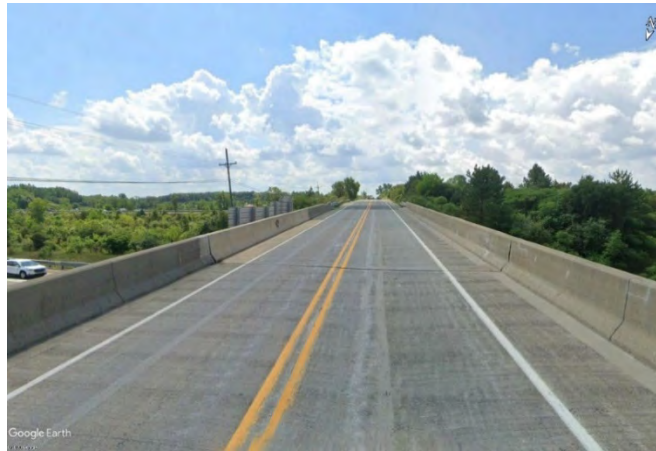
Figure 82: Pontiac Trail Crossing Westbound US-23/M-14 Facing South

Pontiac Trail crossing eastbound and westbound US-23/M-14 has an available roadway width of 3.8 feet and lengths of 195.8 and 149.6 feet, respectively. There are not any non-motorized facilities on these crossings. Adjacent non-motorized facilities include bike lanes on both sides that end in advance of Pontiac Trail crossing eastbound US-23/M-14. **Figures 82** and **83** show a street view of these crossings, respectively.

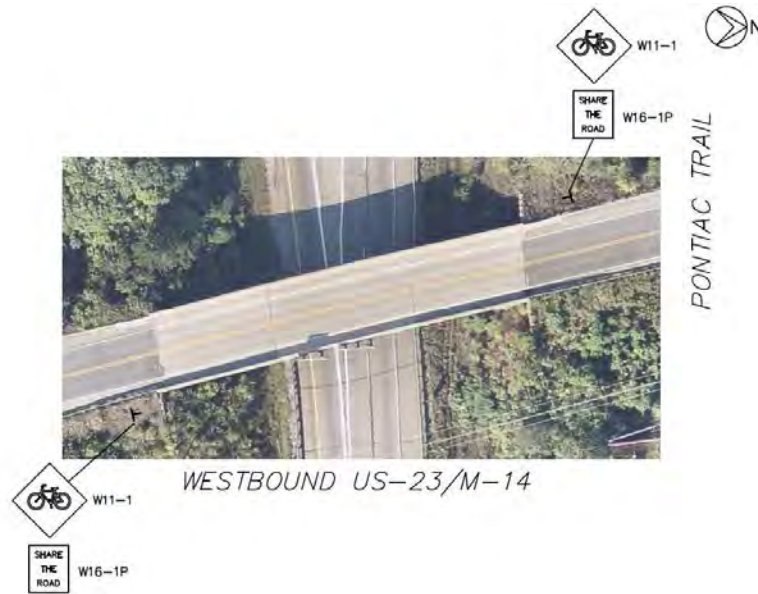
**Figure 84: Proposed Bicycle Warning Signs and Plaques at Pontiac Trail Crossing Westbound US-23/M-14**

A Bicycle Warning Sign and a SHARE THE ROAD plaque could be added in advance of each crossing on both sides, which would cost approximately \$500. **Figure 84** shows a concept of the proposed bicycle warning signs and plaques at Pontiac Trail crossing westbound US-23/M-14. The concept for Pontiac Trail crossing eastbound US-23/M14 would be similar.

- With bridge condition ratings of four and five, rehabilitation and preventative maintenance is expected to be performed. The bicycle warning signs and plaques could be coordinated during this time.
- Treatments should be applied to Pontiac Trail between the crossings to make segment consistent.
- A reduced shared path width of eight feet may be suitable since the area is more rural.

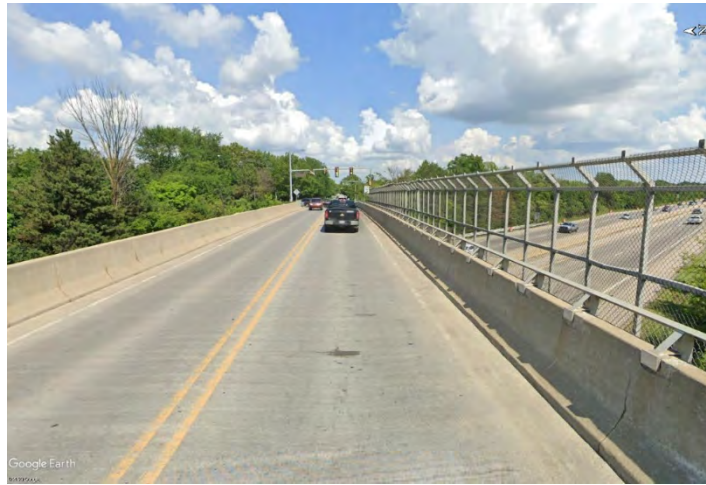
**Figure 85: Scio Church Road Crossing I-94 Facing East**

Scio Church Road crossing I-94 does not have any available roadway width and has a length of 293 feet. Non-motorized facilities on this crossing include an eastbound sidewalk with a separation barrier and fencing. Adjacent non-motorized facilities include an eastbound sidewalk that ties into the crossing and a westbound sidewalk that ends in advance of the crossing. **Figure 85** shows a street view of this crossing.

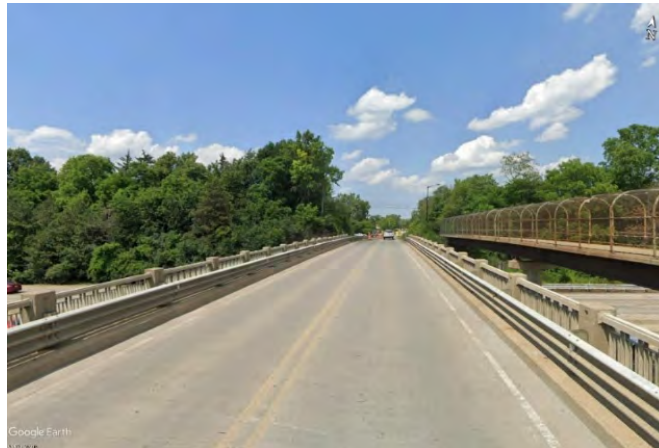
**Figure 87: Stone School Road Crossing I-94 Facing North**

Stone School Road crossing I-94 does not have any available roadway width and has a length of 208.3 feet. Non-motorized facilities on this crossing include a northbound shared path bridge with fencing. Adjacent non-motorized facilities include a northbound shared path that ties into the crossing. **Figure 87** shows a street view of this crossing.

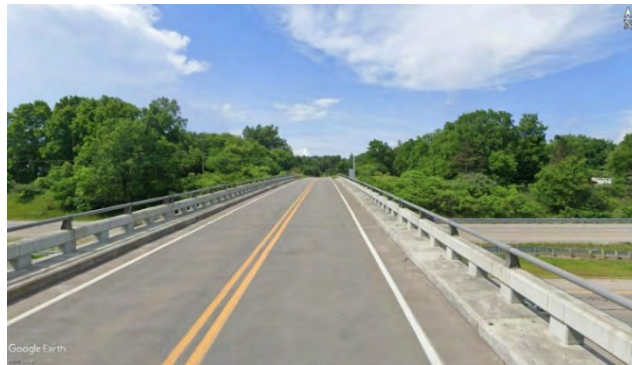
**Figure 88: Vorhies Road Crossing M-14 Facing North**

Vorhies and Wagner Road crossing M-14 have available roadway widths of 1.9 feet and lengths of 316.9 and 375.8 feet, respectively. Non-motorized facilities on these crossings include a sidewalk on both sides. There are not any non-motorized facilities adjacent to these crossings. **Figures 88 and 89** show a street view of these crossings, respectively.

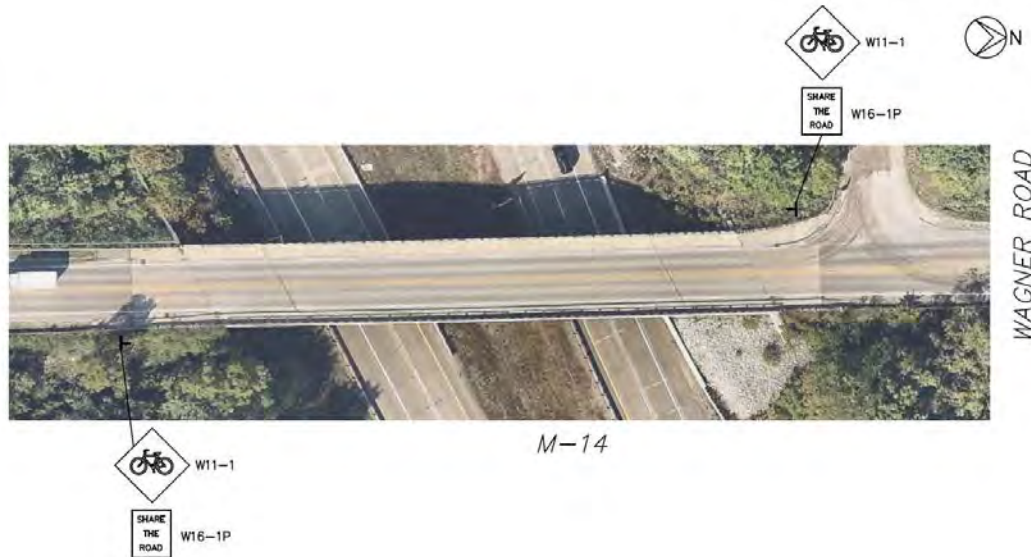
**Figure 90: Proposed Bicycle Warning Signs and Plaques at Wagner Road Crossing M-14**

A Bicycle Warning sign and a SHARE THE ROAD plaque could be added in advance of the crossing on both sides, which would cost approximately \$500. **Figure 90** shows a concept of the proposed bicycle warning signs with plaques at Wagner Road crossing M-14. Vorhies Road crossing M-14 would be similar.

- With a bridge condition rating of five, preventative maintenance is expected to be performed. The bicycle warning signs with plaques could be coordinated during this time.
- A reduced shared path width of eight feet may be suitable for Vorhies Road since the area is more rural.

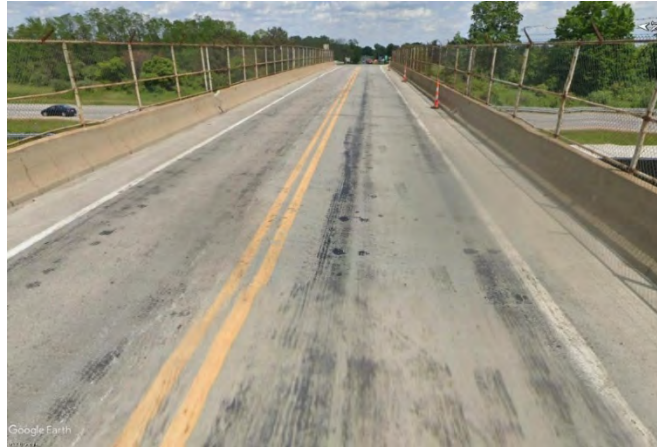
**Figure 91: Street View of Willis Road Crossing US-23 Facing East**

Willis Road crossing US-23 has an available roadway width of 5.1 feet and a length of 265 feet. Non-motorized facilities on this crossing include fencing. There are not any non-motorized facilities adjacent to this crossing. **Figure 91** shows a street view of this crossing.

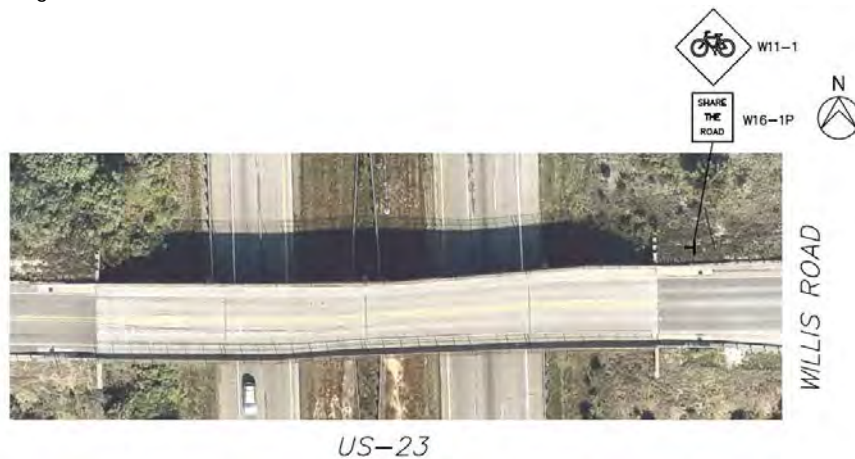
**Figure 92: Proposed Bicycle Warning Signs and Plaques at Willis Road Crossing US-23**

A westbound Bicycle Warning sign and a SHARE THE ROAD plaque could be added in advance of the crossing, which would cost approximately \$250. **Figure 92** shows a concept of the proposed bicycle warning signs and plaques at this crossing.

- With a bridge condition rating of four, rehabilitation is expected to be performed. The bicycle warning sign and plaque and walkway lighting could be coordinated during this time.
- No eastbound treatments are being proposed due to the free-flow northbound on-ramp.
- A reduced shared path width of eight feet may be suitable since the area is more rural.

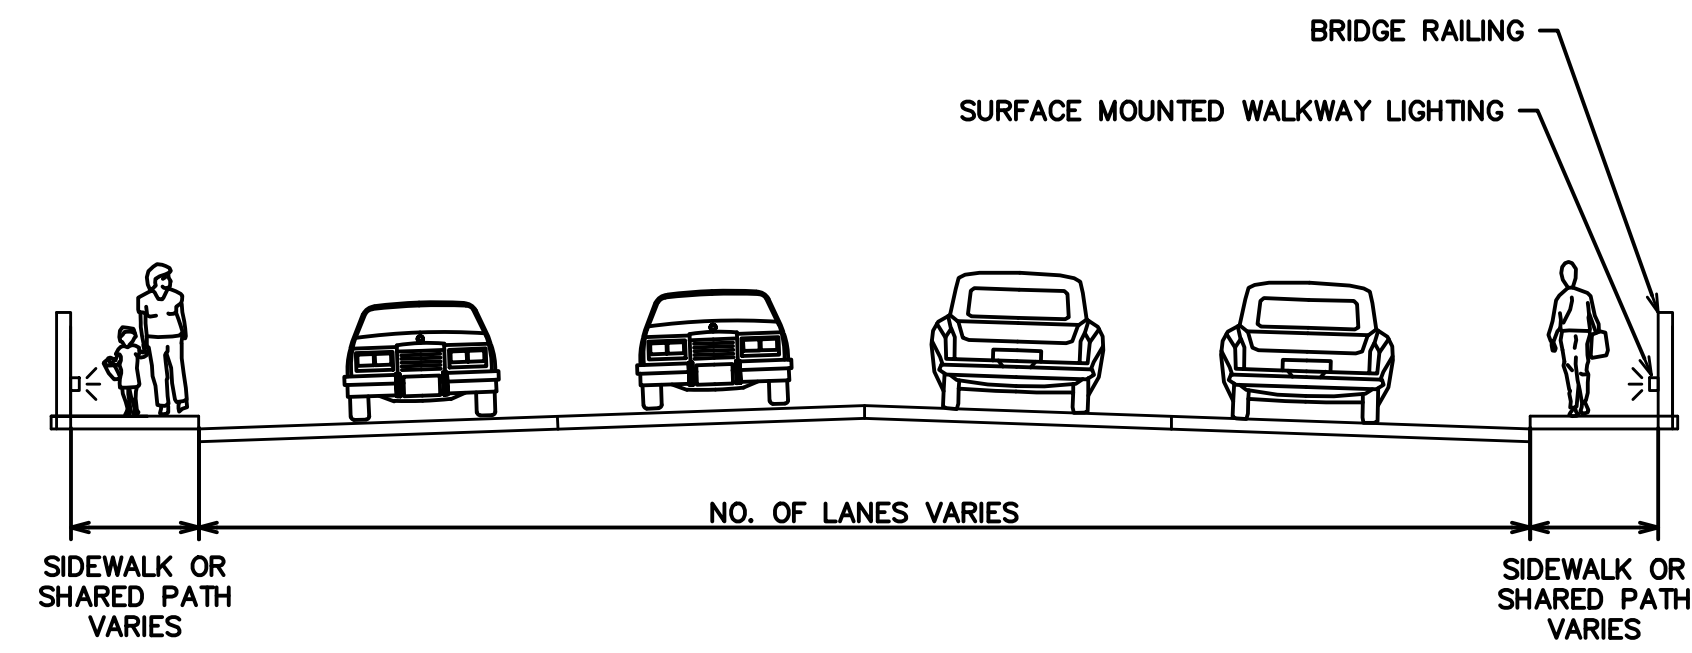
**TYPICAL SECTION – SURFACE MOUNTED WALKWAY LIGHTING**

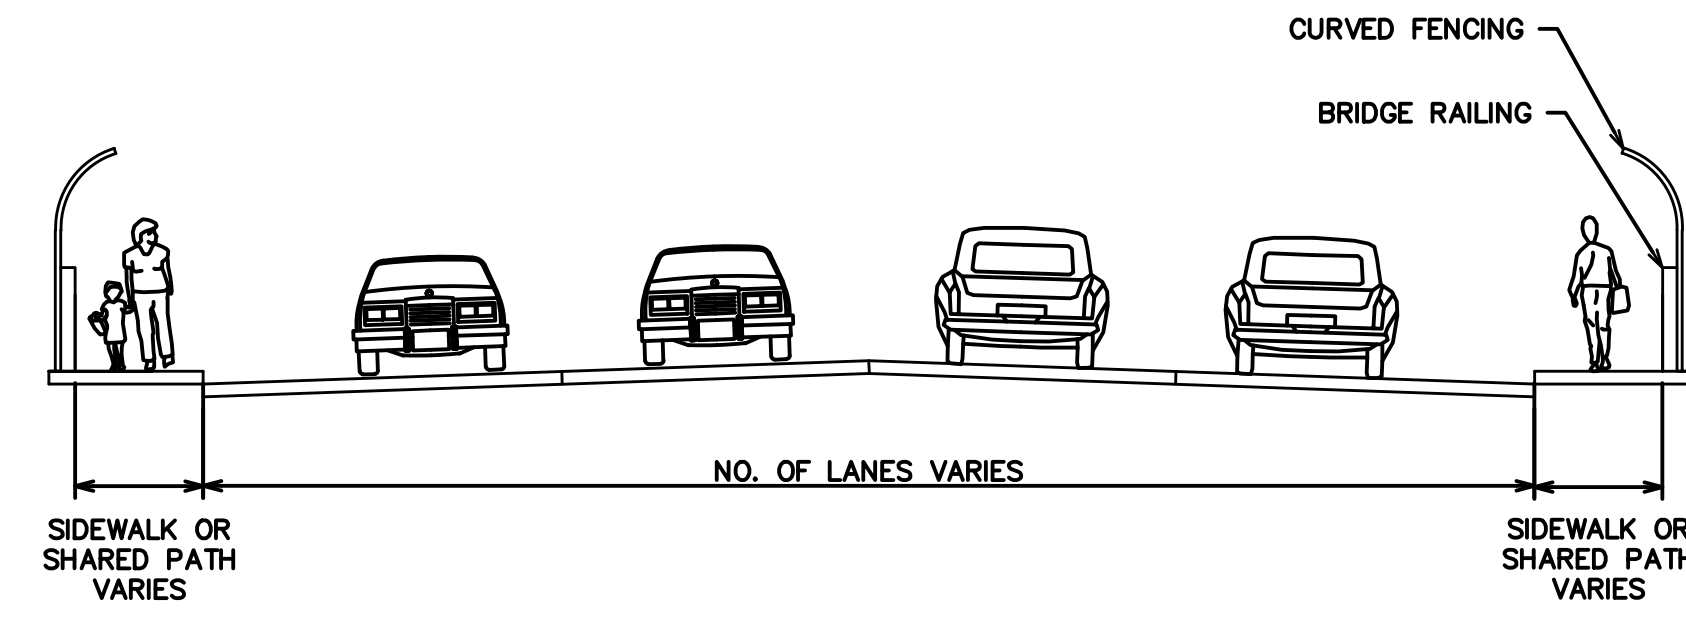
**TYPICAL SECTION – CURVED FENCING**

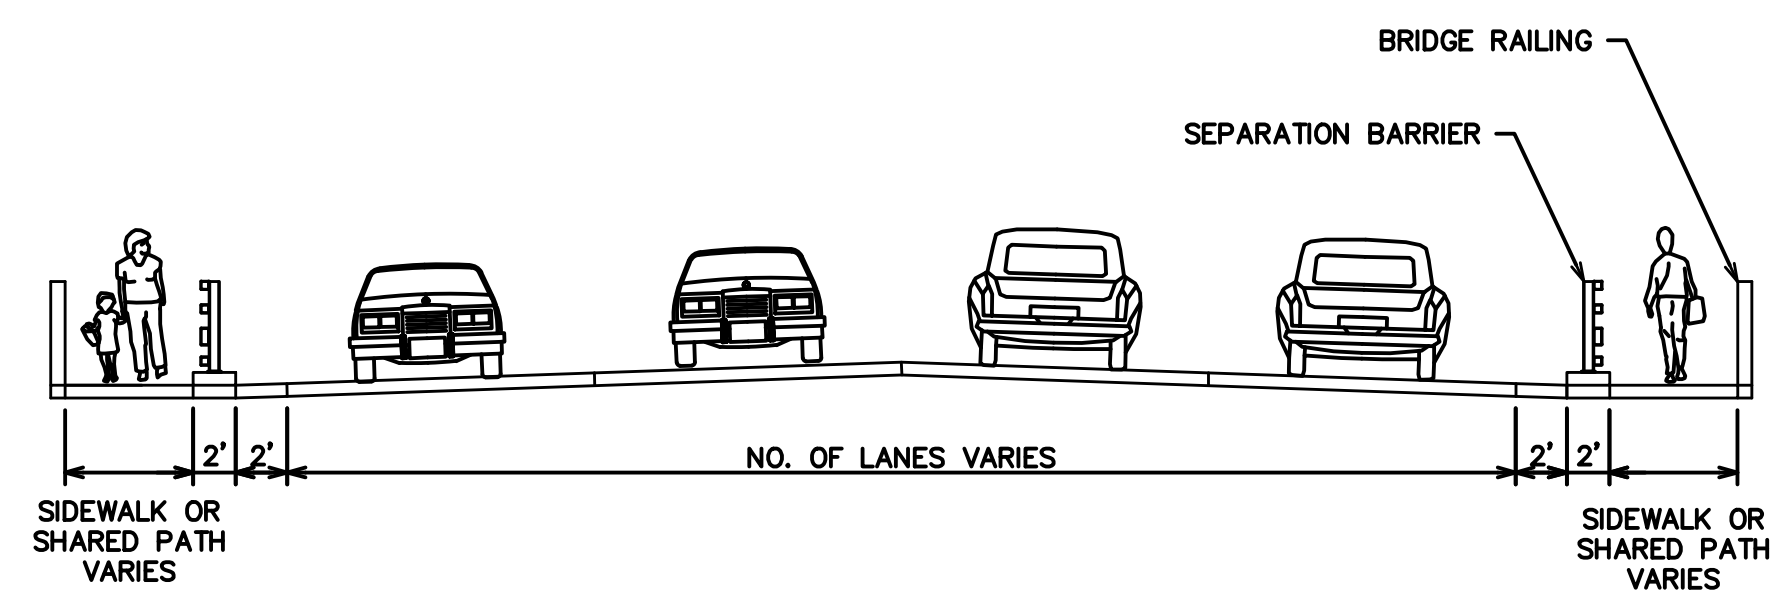
**TYPICAL SECTION – SEPARATION BARRIER**

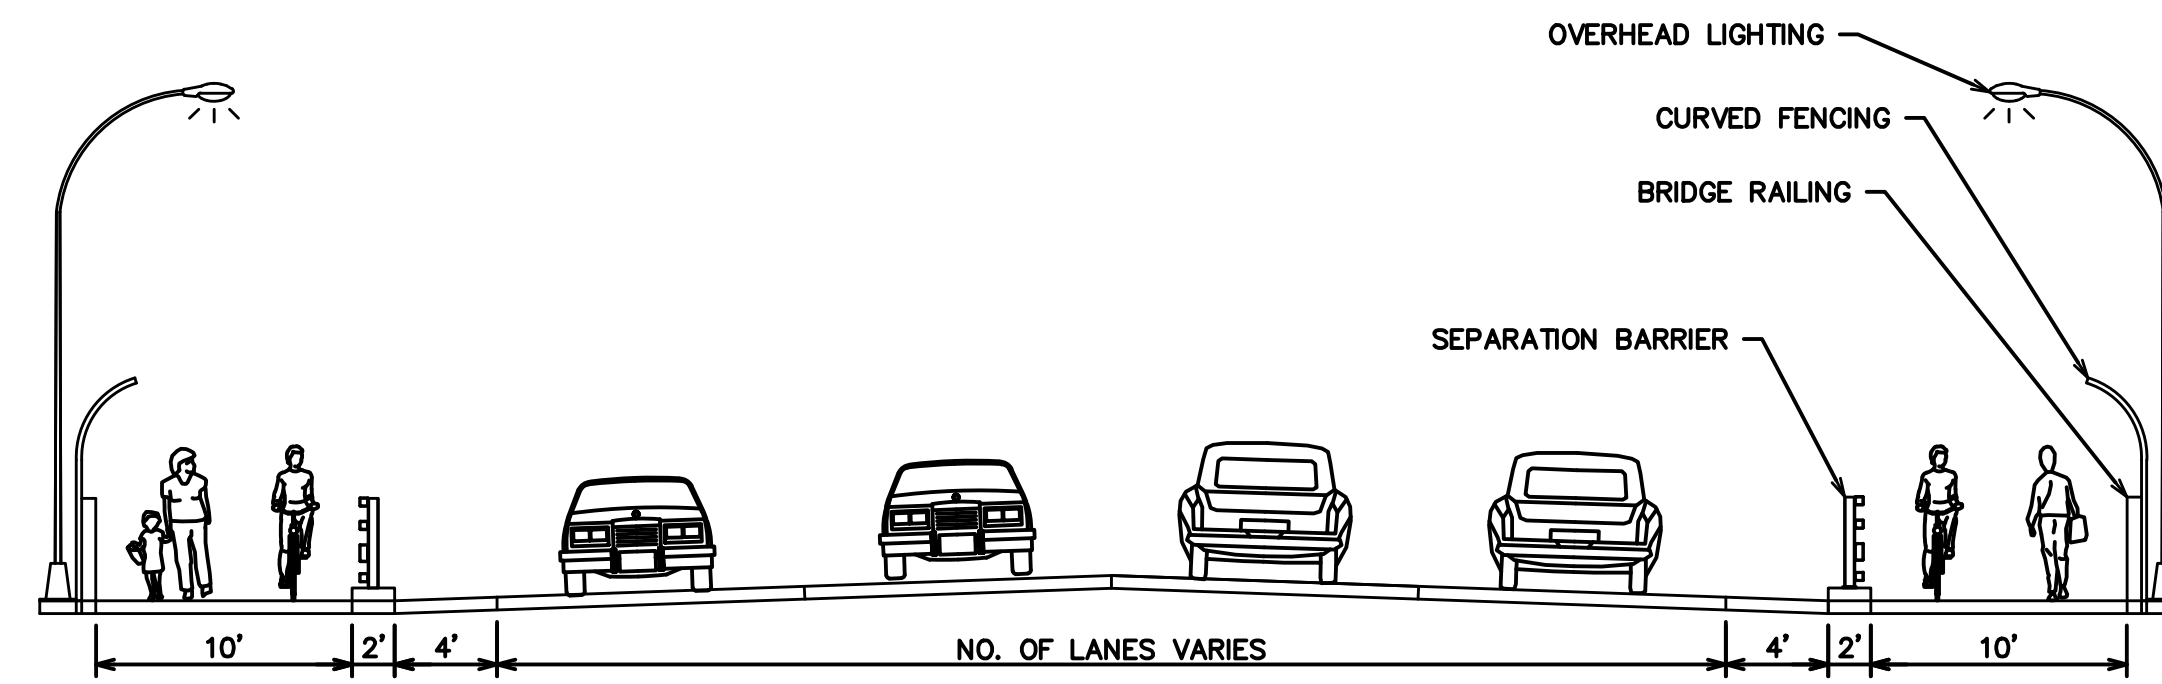
**TYPICAL SECTION – SHARED PATH WITH SEPARATION BARRIER, CURVED FENCING, LIGHTING**

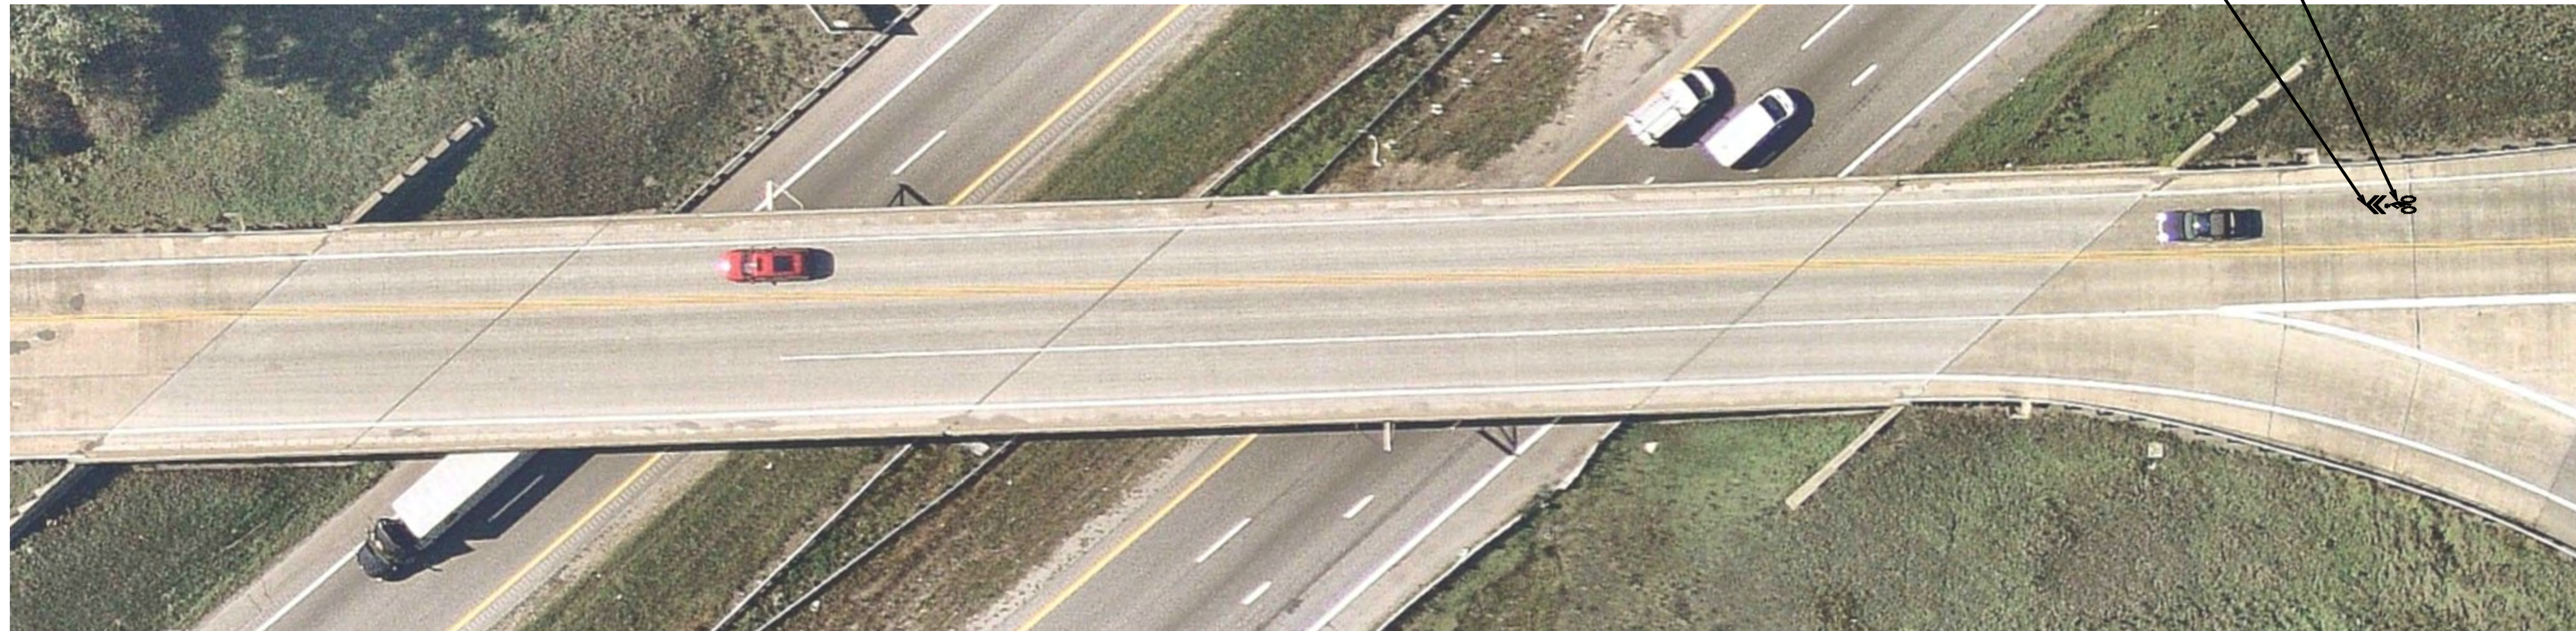
PROPOSED BIKE LANES AND  
 NEW LANE GEOMETRY  
 CARPENTER RD  
 CROSSING I-94

SMALL BIKE SYMBOL

SHARED LANE MARKING
