# FREEWAY CROSSING NON-MOTORIZED RETROFIT

FOR WASHTENAW AREA TRANSPORTATION STUDY

Final Report: June 30, 2020  
HRC Job No. 20191021

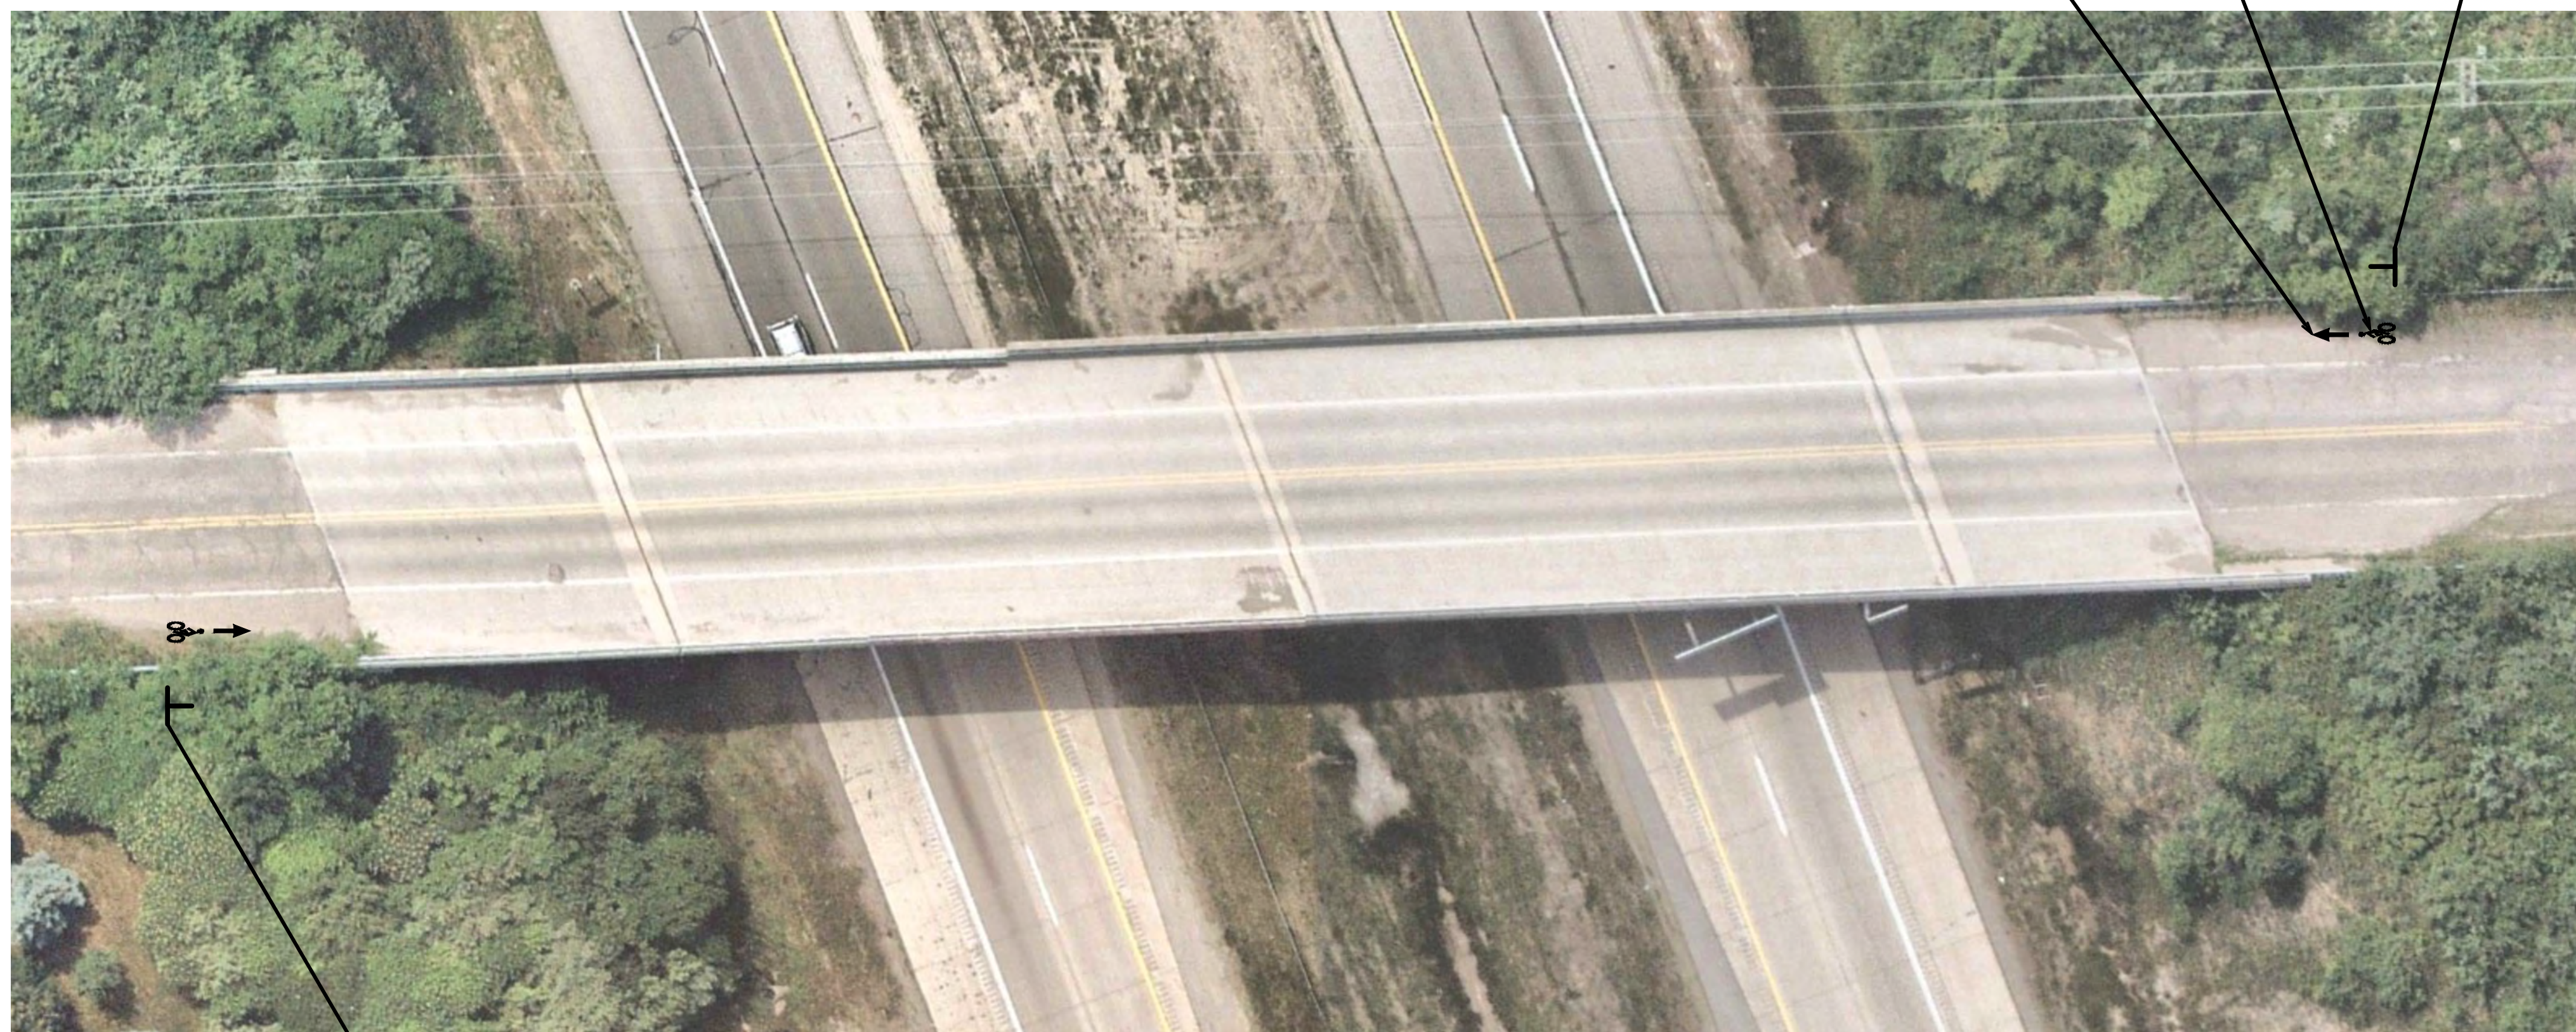
HRC JOB NO. 20191021	SCALE 1" = 20'
DATE June 2020	SHEET NO. 23

PROP. BIKE SIGNS & PLAQUES  
 MILLER RD  
 CROSSING M-14

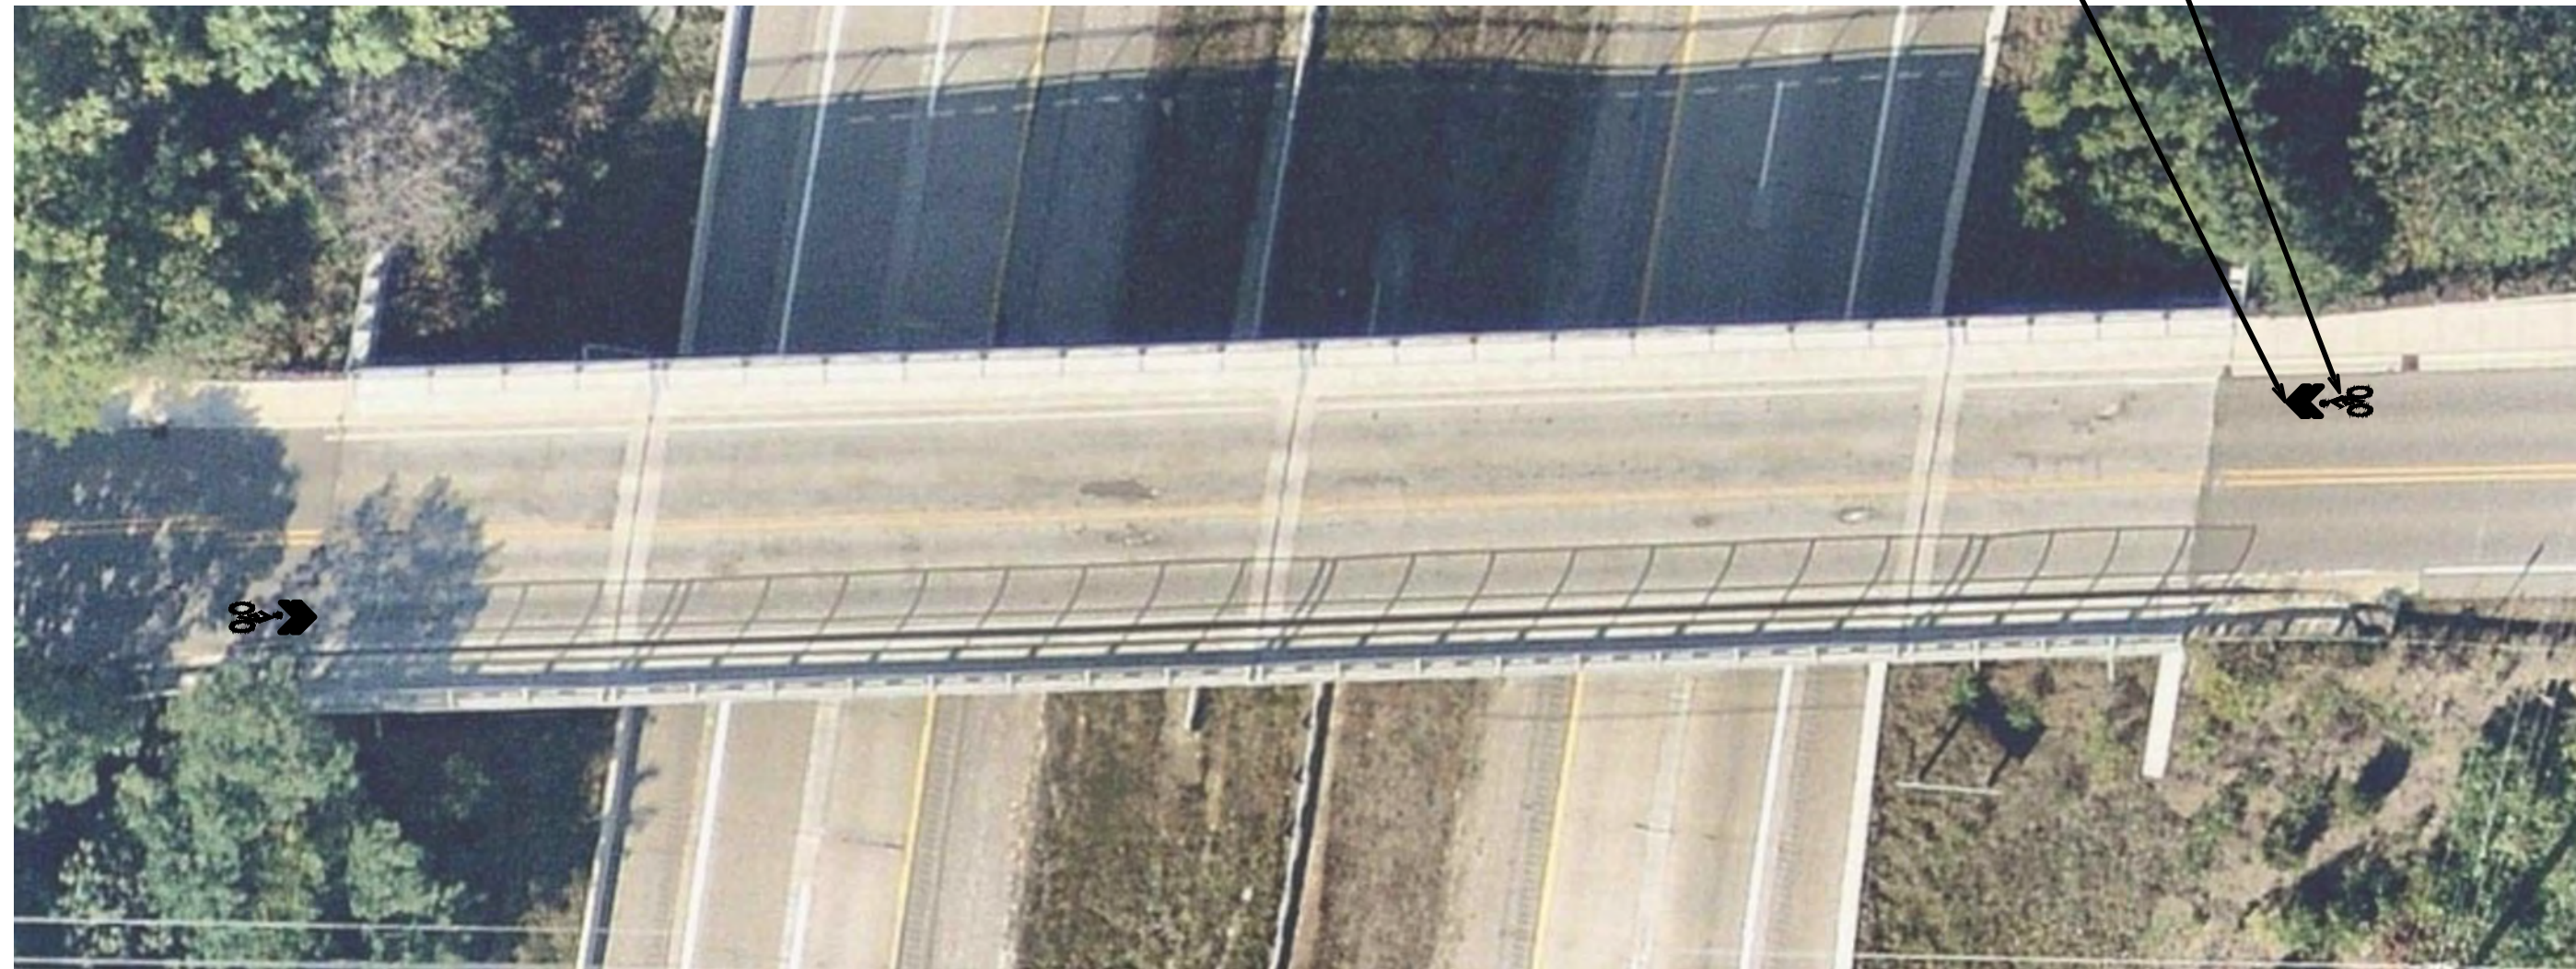
HRC JOB NO. 20191021	SCALE 1" = 20'
DATE June 2020	SHEET NO. 24

PROPOSED BIKE LANES  
 NAPIER RD  
 CROSSING M-14

SMALL BIKE SYMBOL (TYP.)

SHARED LANE MARKING (TYP.)

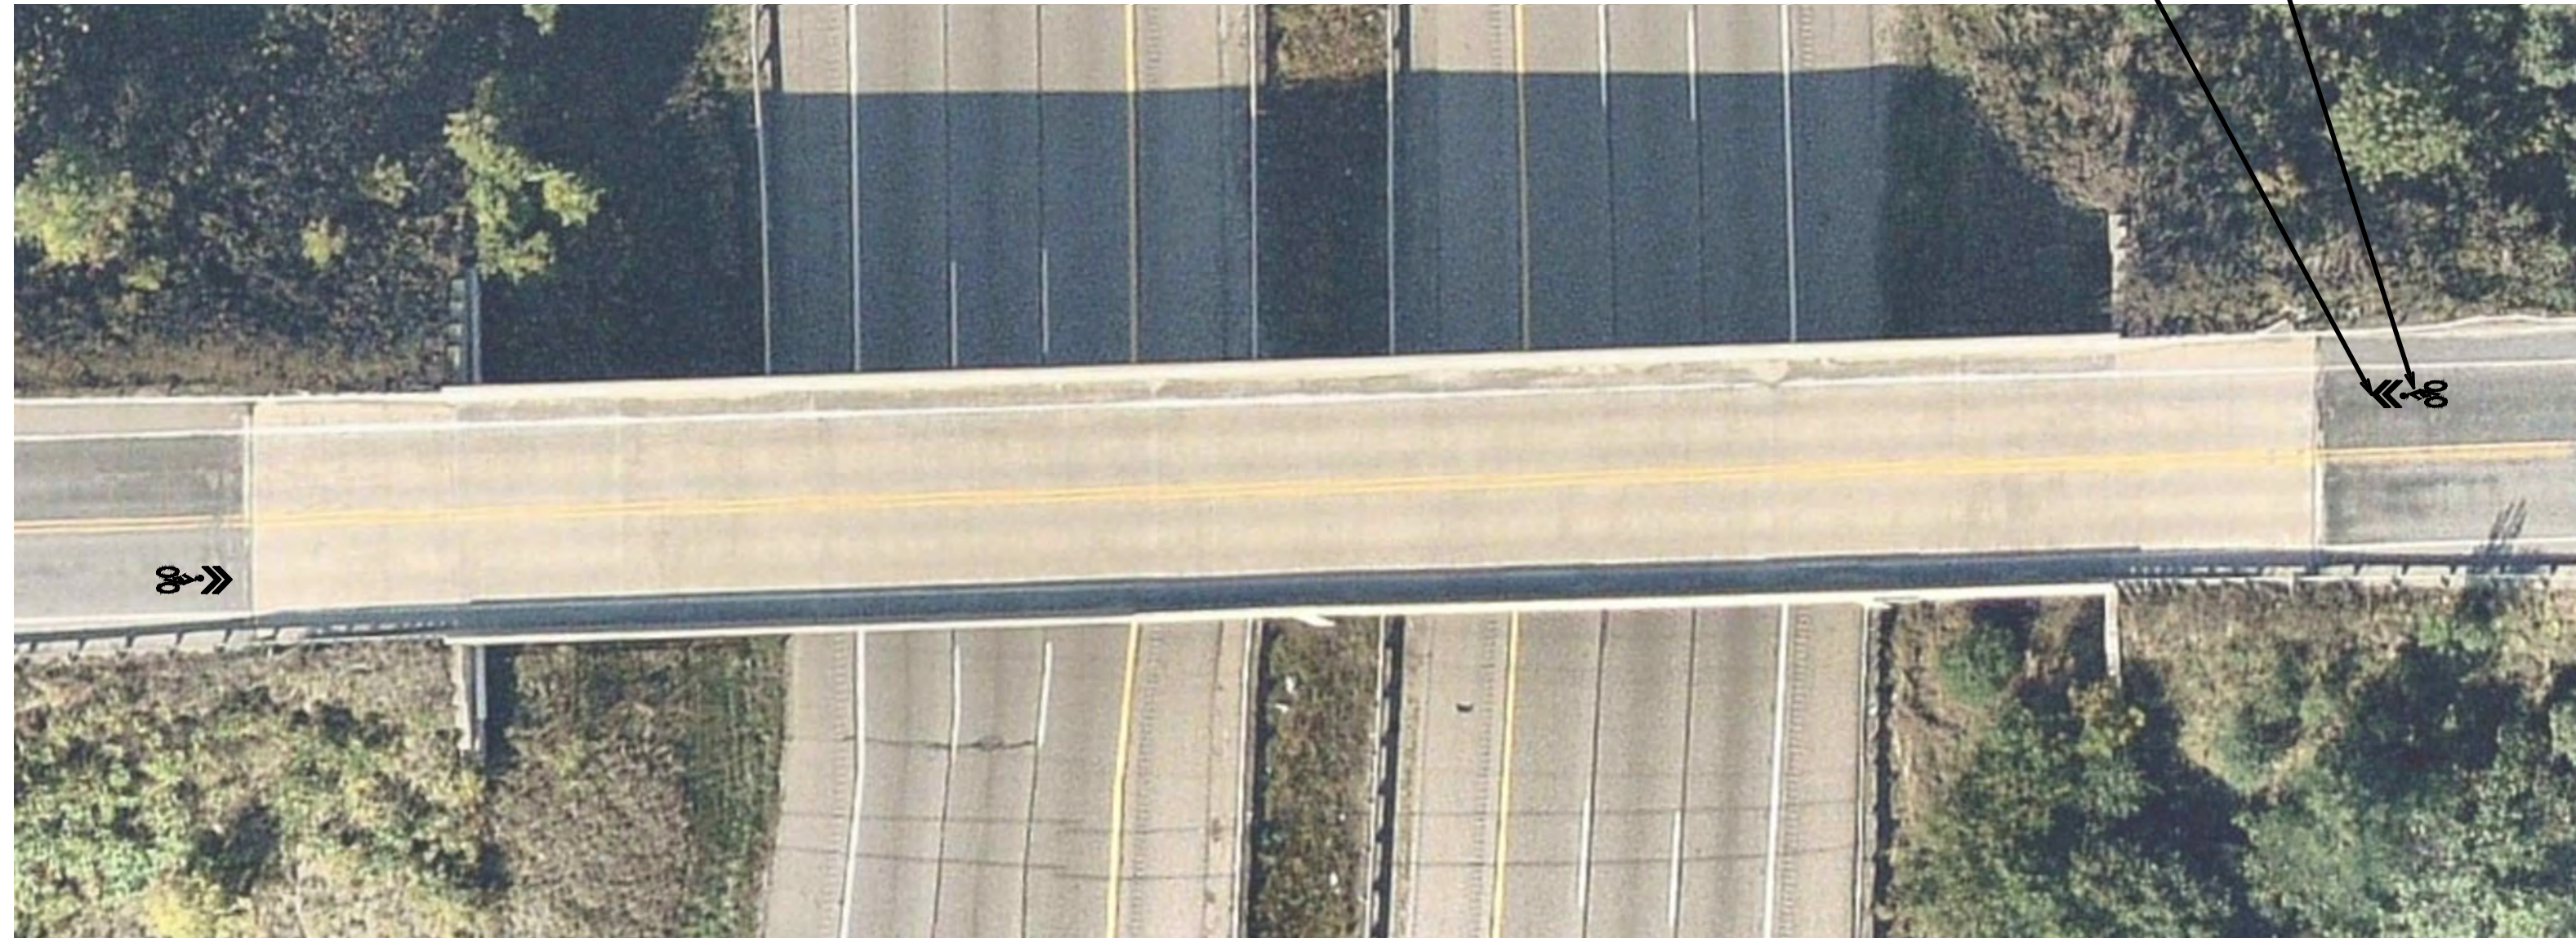
HRC JOB NO. 20191021	SCALE 1" = 20'
DATE June 2020	SHEET NO. 25

PROPOSED SHARED LANES  
 NEWPORT RD  
 CROSSING M-14

SMALL BIKE SYMBOL (TYP.)  
 SHARED LANE MARKING (TYP.)

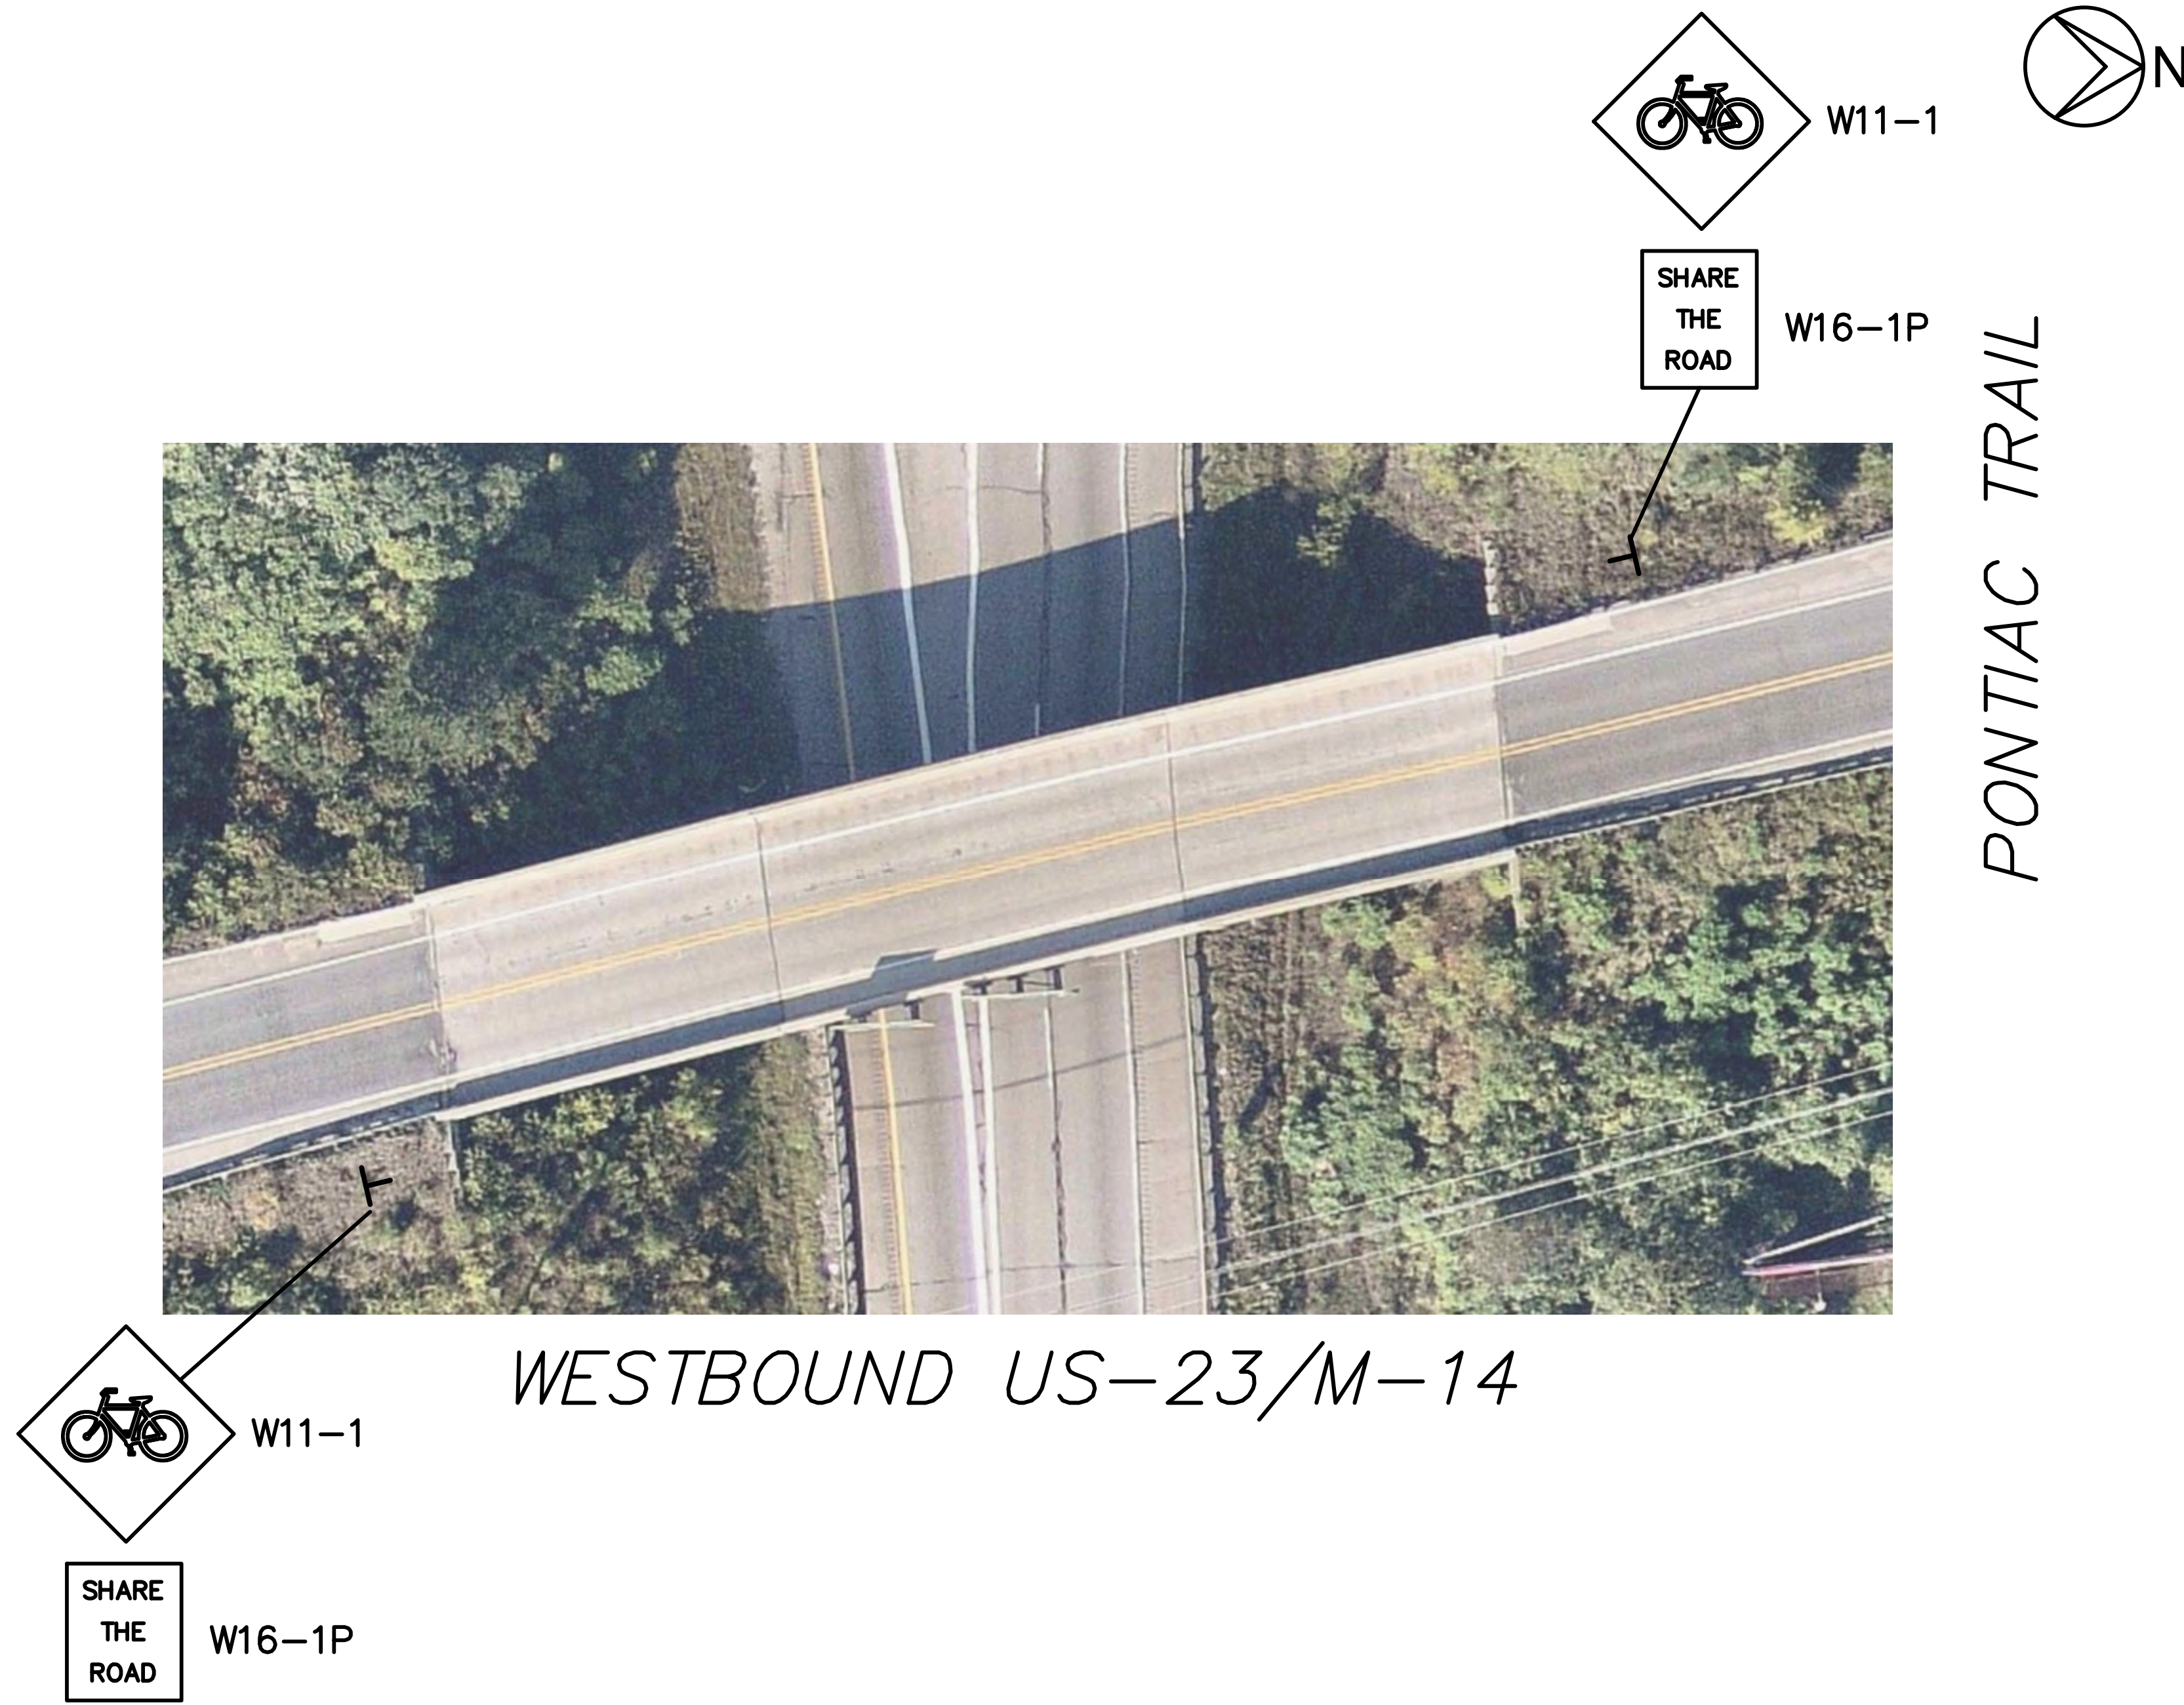
HRC JOB NO. 20191021	SCALE 1" = 20'
DATE June 2020	SHEET NO. 26

PROPOSED SHARED LANES  
 NIXON RD  
 CROSSING US-23

- With bridge condition ratings of five and six, preventative maintenance is expected to be performed. The shared lanes could be coordinated during this time.
- A reduced shared path width of eight feet may be suitable for Nixon Road since the area is more rural.

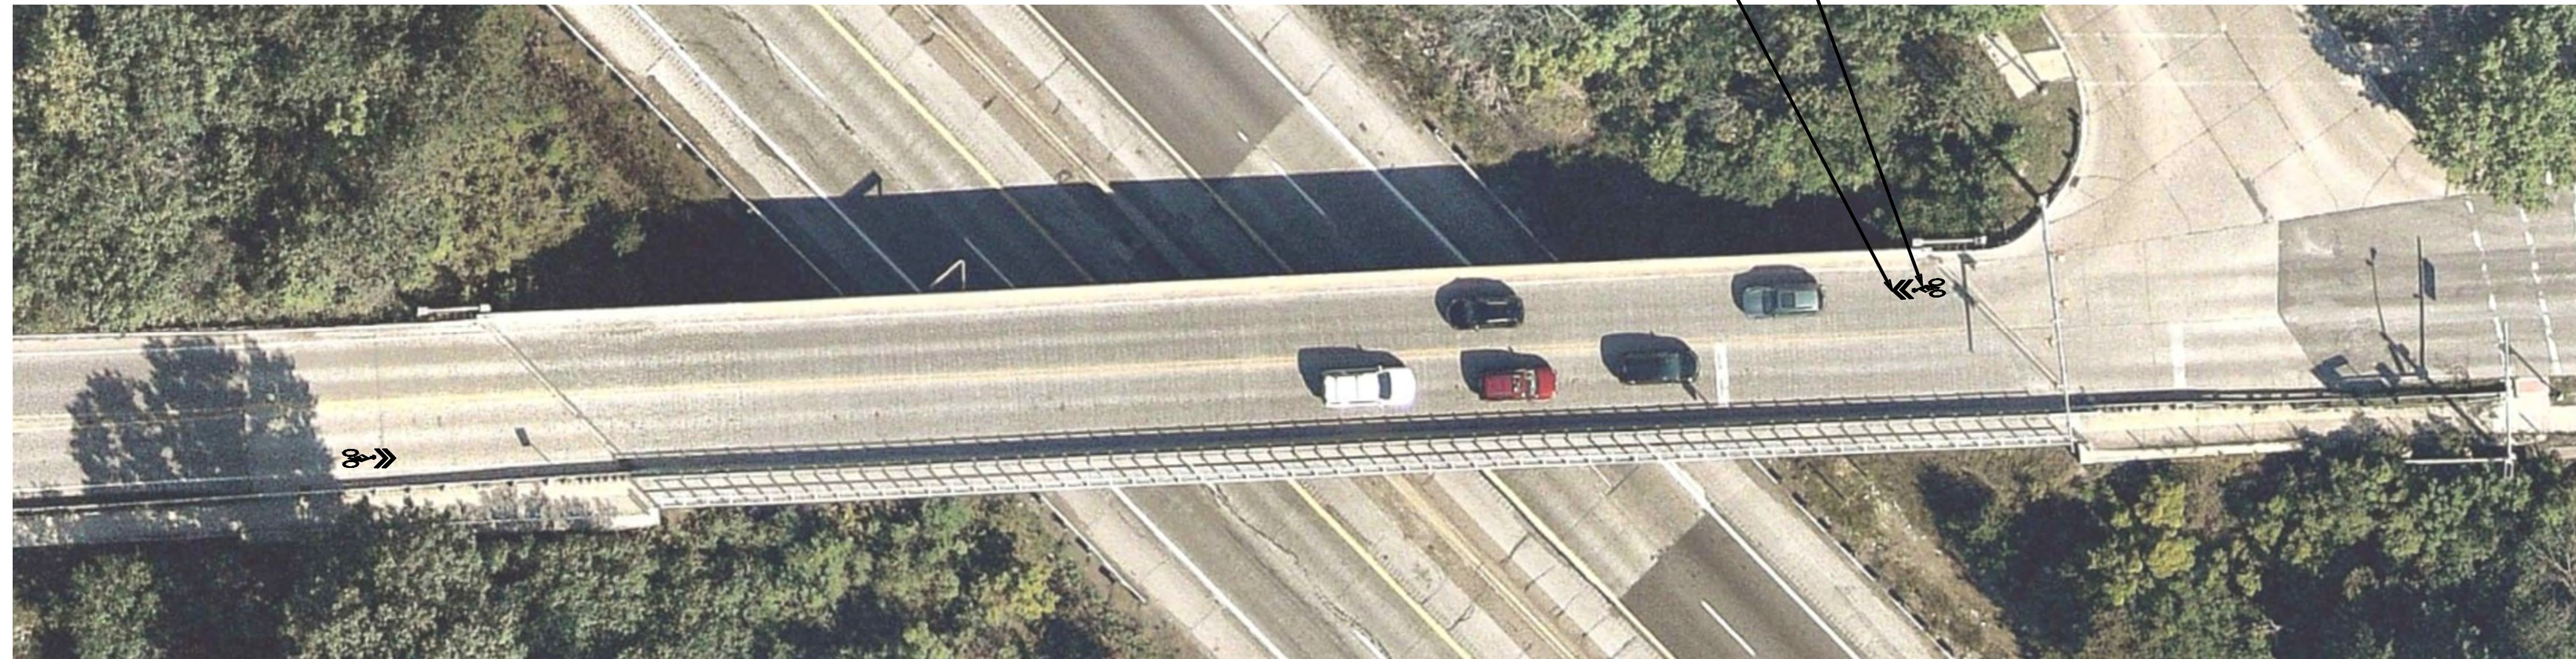
HRC JOB NO. 20191021	SCALE 1" = 20'
DATE June 2020	SHEET NO. 28

PROP. BIKE SIGNS & PLAQUES  
 PONTIAC TRAIL  
 CROSSING WB US-23/M-14

SMALL BIKE SYMBOL (TYP.)

SHARED LANE MARKING

- With bridge condition ratings of four and five, rehabilitation and preventative maintenance is expected to be performed. The bicycle warning signs and plaques could be coordinated during this time.
- Treatments should be applied to Pontiac Trail between the crossings to make segment consistent.
- A reduced shared path width of eight feet may be suitable since the area is more rural.

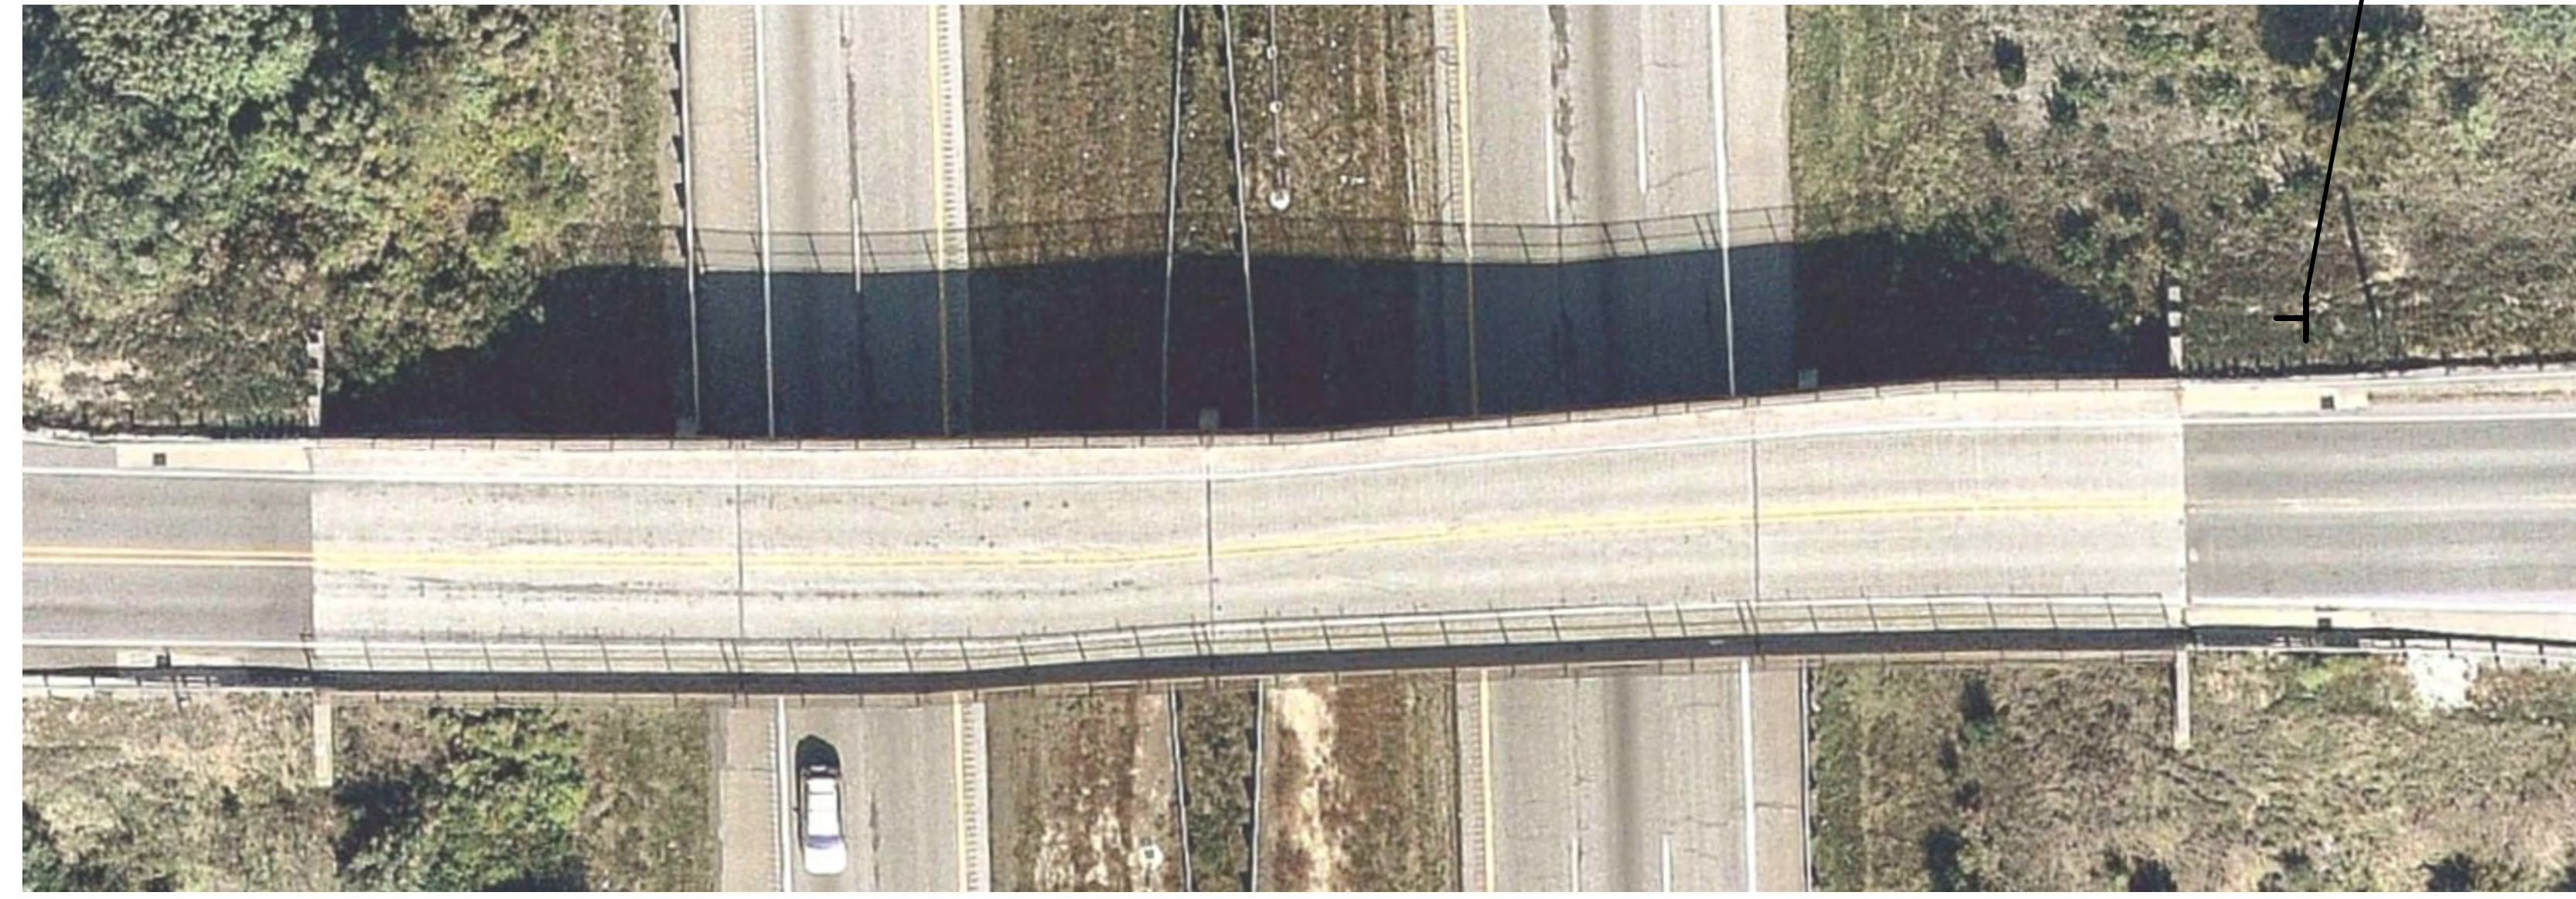
HRC JOB NO. 20191021	SCALE 1" = 20'
DATE June 2020	SHEET NO. 31

PROP. BIKE SIGNS & MRKGS.  
 SIX MILE RD  
 CROSSING US-23
